Your Ref: TP/IP/46761/2018
Our Ref : CI/TPD18018440/Z

09th January 2019

MECHANICAL INSPECTION REPORT OF MOTOR CAR SKC 3331D

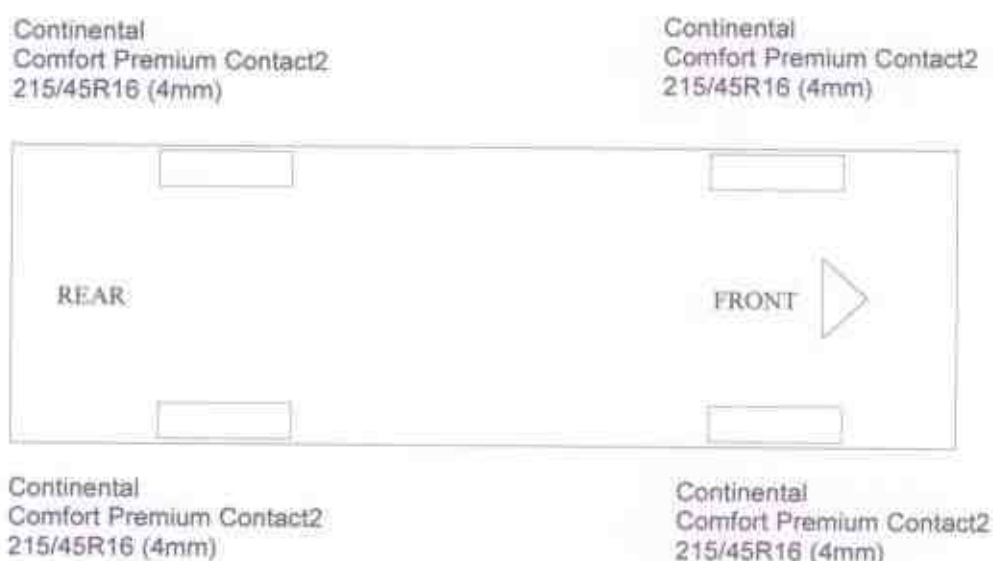
7. The condition of the Motor Car's 4 tyres was observed to be in serviceable condition. We did not find any tear, cut or burst mark(s) on the outer and the inner sidewalls as well as across the tread of the 4 tyres. The 4 tyres were also observed to be sufficiently inflated for vehicular operation. The tyre brand, tyre size and remaining tread depth of the 4 tyres were recorded as follows:-
