MECHANICAL INSPECTION REPORT OF MOTOR TAXI SHC 8268G

1. We refer to your request on 27th September 2018 to conduct a physical inspection of a motor taxi bearing registration number SHC 8268G (herein referred to as "**Motor Taxi**"), which was involved in a fatal road traffic accident on 15th September 2018.
2. The objective of the inspection is to determine if there was any possible mechanical failure to the Motor Taxi that may have contributed to the accident.
3. Following the request, we had carried out a physical inspection of the Motor Taxi on 26th October 2018 at the premises of Traffic Police vehicle pound, 517 Airport Road Singapore 539942. We now set out below our observations and comments with respect to this inspection.

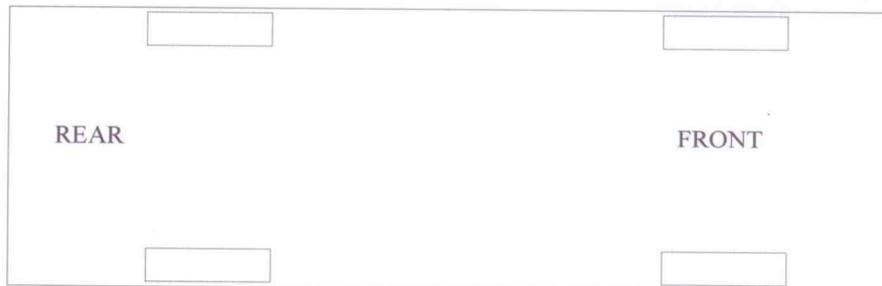
- The condition of the Motor Taxi's 4 tyres was observed to be in serviceable condition. We did not find any tear, cut or burst mark(s) on the outer and the inner sidewalls as well as across the tread of the 4 tyres. The 4 tyres were also observed to be sufficiently inflated for vehicular operation. The tyre brand, tyre size and remaining tread depth of the 4 tyres were recorded as follows:-

CST 920 Campeon 205/60R16 (7mm)

CST 920 Campeon 205/60R16 (6mm)
