Your Ref : TP/IP/55759/2018
Our Ref : CI/TPD18019471/Z

31st December 2018

MECHANICAL INSPECTION REPORT OF MOTORCYCLE JRB 2580

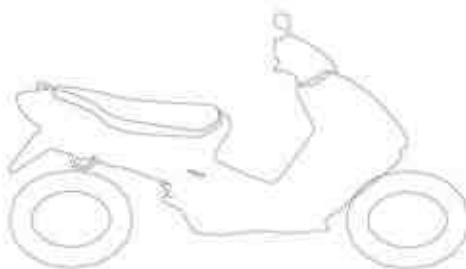
7. The condition of the Motorcycle's rear tyre was observed to be in serviceable condition. The tread pattern of the rear tyre was clearly visible. We did not observe any tear, burst mark(s) and/or punctured hole(s) on the sidewalls as well as across the tread of the rear tyre. The tyre brand, tyre size and remaining tread depth of the 2 tyres were recorded as follows:-

Maxxis 80/90 – 17(4mm)

Maxxis 70/90 – 17(3mm)
