Your Ref: TP/IP/55759/2018
Our Ref : CI/TPD18019472/Z

Fatal Accident Investigation Team

MECHANICAL INSPECTION REPORT OF MOTOR VAN GR 8267S

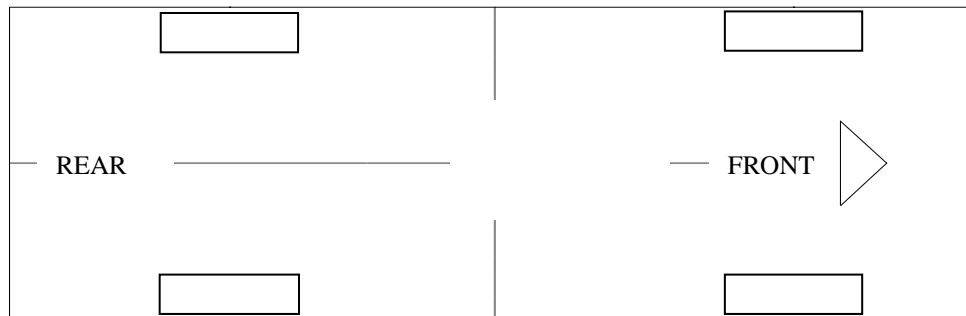
7. The 4 tyres were observed to be in serviceable condition and sufficiently inflated for vehicular operation. We did not find any tear, cut or burst mark(s) on the outer and the inner sidewalls as well as across the tread of the 4 tyres. The tyre brand, tyre size and remaining tread depth of the 4 tyres of the Motor Van were recorded as follows:-

Falken Linam R51X 185R14C (2mm)

Delium Power Saver 185R14C (5mm)
