Your Ref: TP/IP/52309/2018
Our Ref : CI/TPD18019476/Z

11th March 2019

MECHANICAL INSPECTION REPORT OF TIPPER TRUCK XD 4360D

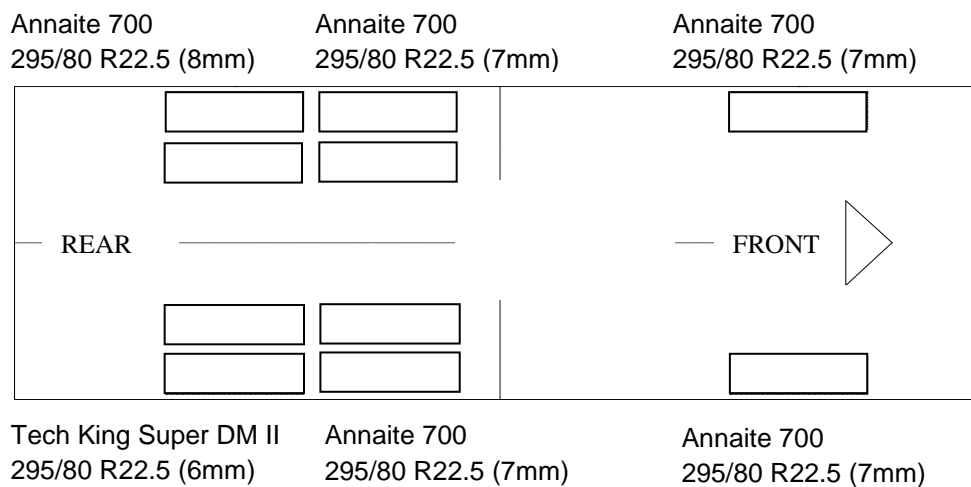
7. The 10 tyres fitted on the Tipper Truck were all observed to be in serviceable condition. We did not find any tear, cut or burst mark(s) on the outer and the inner sidewalls as well as across the tread of the 10 tyres.
8. However, front right tyre, rear left middle outer tyre, rear left outer tyre, rear right middle outer tyre & rear right outer tyre were observed to be deflated likely due to the stationery position for a long period of time which in turn causes the abovementioned tyres to sustained loss of air pressure.
9. The tyre brand, tyre size and remaining tread depth of the Tipper Truck's 10 tyres were recorded as follows:-

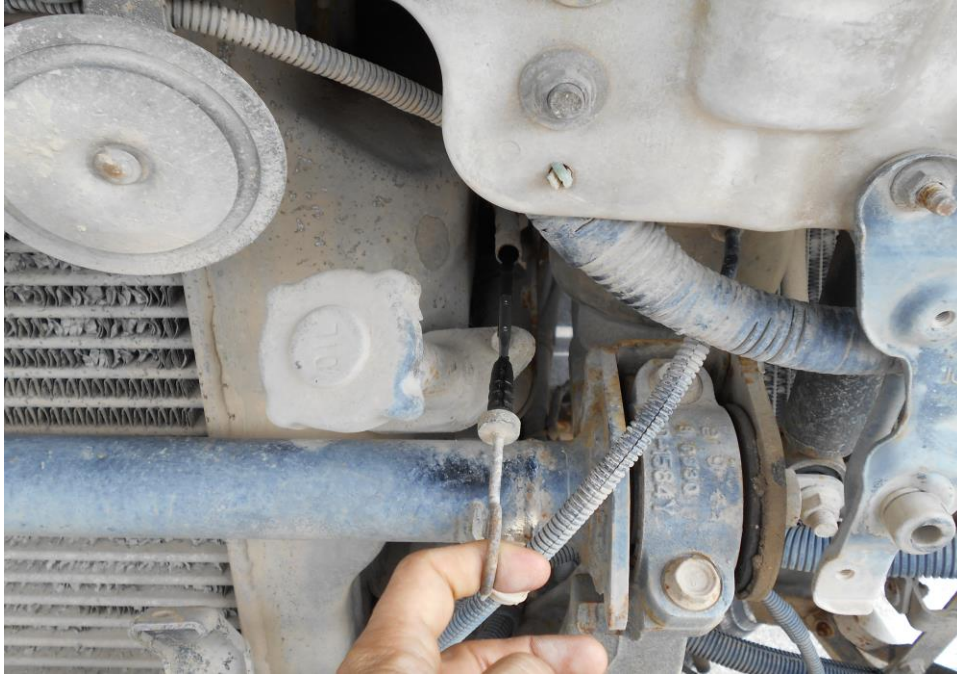
Photo 18 shows a close-up view of the dip stick which was located at the front bonnet.

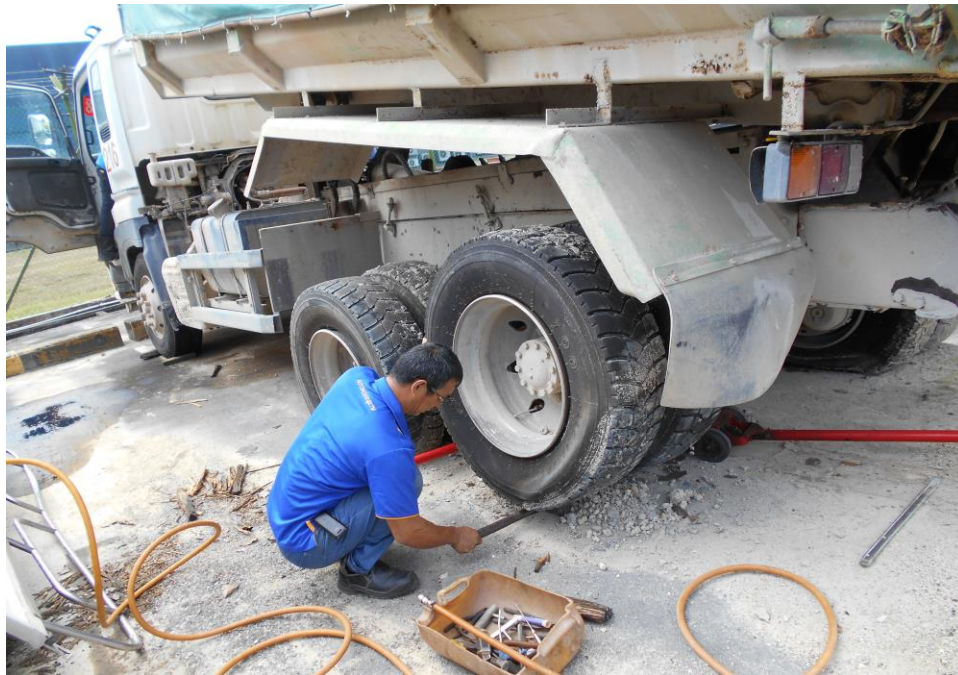
20. All the deflated tyres were firstly prepared before the operational test. A team of tyre mechanics were deployed to prepare and pumped up the deflated tyres for operational test purposes.
21. During the operational test, the transmission system of the Tipper Truck was able to be shifted to drive mode and reverse mode without any difficulty. There were no abnormal sounds heard and/or abnormal behaviour of the Tipper Truck's engine system. The braking system was also found to be in working condition. See photo 36 below.

Photo 36 shows a general view tyre mechanic tried to pumped up the deflated tyres of the Tipper Truck for operational purposes.
