Auto  
Consultants  
Pte Ltd

26 October 2018

**Incident On 29 April 2016 At About 1645hrs Along Pasir  
Ris Drive 1 Towards Pasir Ris Drive 12, Involving A  
Motorcycle FBK 7736H**

**Requested By  
Roy & Partners  
101 Cecil Street #11-09  
Tong Eng Building  
Singapore 069533**

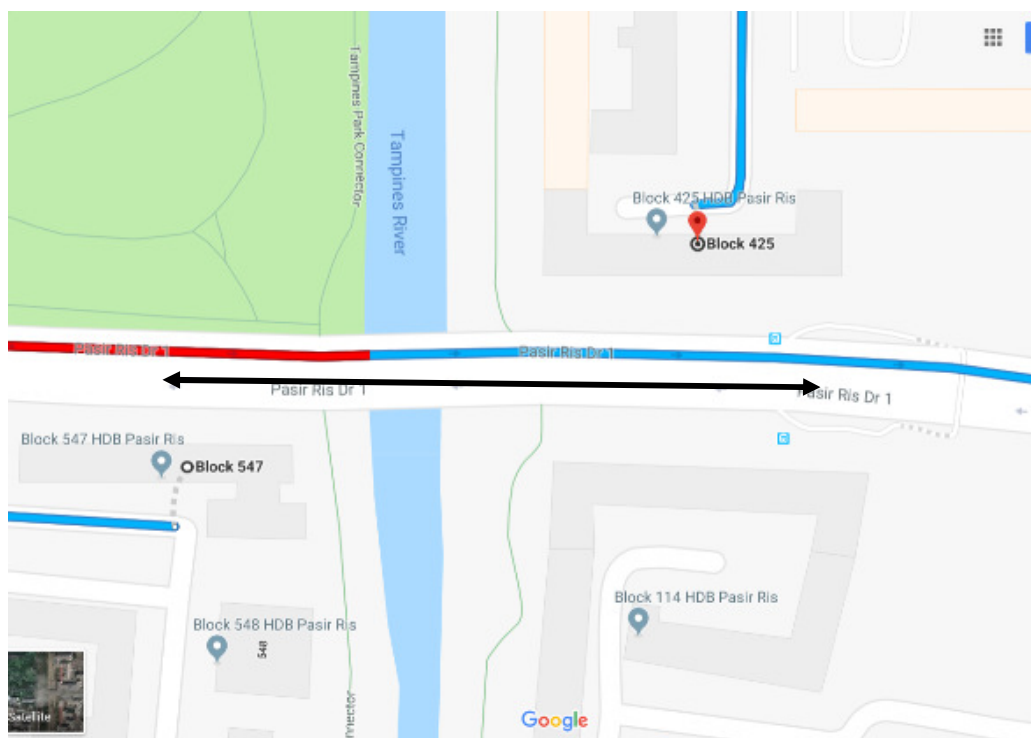
28. Given the unclear accident location contained in Madam Aini's Traffic Police Report, I had established the approximate accident location from information contained in the Police First Information Report and the SCDF Ambulance Report. The accident location was established to be along Pasir Ris Drive 1 towards Pasir Ris Drive 12, along the stretch of roadway between Block 425 and Block 547. See Google map below.

Screenshot taken from Google Maps shows the stretch of roadway of Pasir Ris Drive 1 towards Pasir Ris Drive 12, between Block 547 and Block 425 (highlighted by the black arrow).
