Your Ref: TP/IP/42521/2018
Our Ref: CI/TPD18021189/Z

Fatal Accident Investigation Team
Traffic Police Department
Singapore Police Force
10 Ubi Avenue 3
Singapore 408865

MECHANICAL INSPECTION REPORT OF MOTORCYCLE FBL 1211P

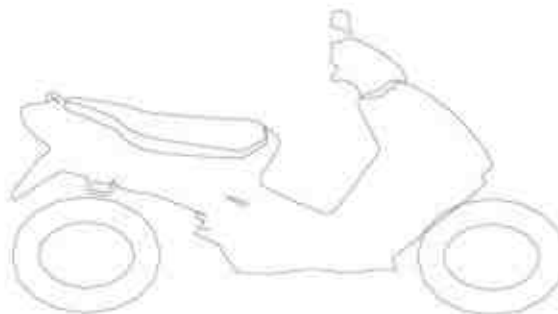
7. The condition of the Motorcycle's both tyres were observed to be in serviceable condition. The tread patterns of the tyres were clearly visible. We did not observe any tear, burst mark(s) and/or punctured hole(s) on the sidewalls as well as across the tread of the tyres. The tyres were observed to be sufficiently inflated for vehicular operation. The tyre brand, tyre size and remaining tread depth of the 2 tyres were recorded as follows:-

Pirelli Diablo Rosso III 190/90 – 17 (3mm)

Pirelli Diablo Rosso III 120/70 – 17 (2mm)
