Your Ref: TP/IP/60763/2018
Our Ref: CI/TPD18022198/Z

22nd January 2019

INSPECTION REPORT OF MOTORCYCLE FBJ 9677L

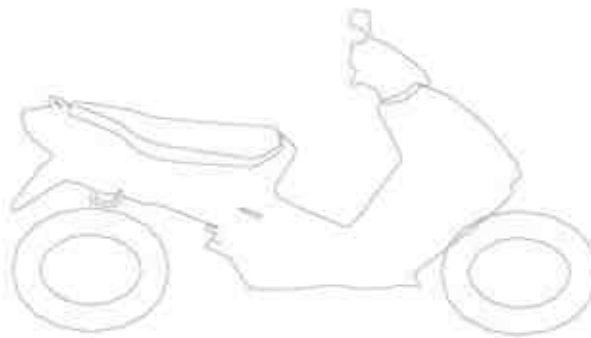
7. The condition of the Motorcycle's 2 tyres was observed to be in serviceable condition. The tread pattern of the 2 tyres was clearly visible. We did not observe any tear, burst mark(s) and/or punctured hole(s) on the sidewalls as well as across the tread of the 2 tyres. The 2 tyres were both observed to be sufficiently inflated for vehicular operation. The tyre brand, tyre size and remaining tread depth of the 2 tyres were recorded as follows:-

Pirelli Diablo 150/70 -13 (4mm)

Michelin City Grip 120/70 -14 (3mm)
