Your Ref: TP/IP/56239/2018
Our Ref :CI/TPD18022200/Z

Fatal Accident Investigation Team

MECHANICAL INSPECTION REPORT OF MOTORCYCLE JPH 1866

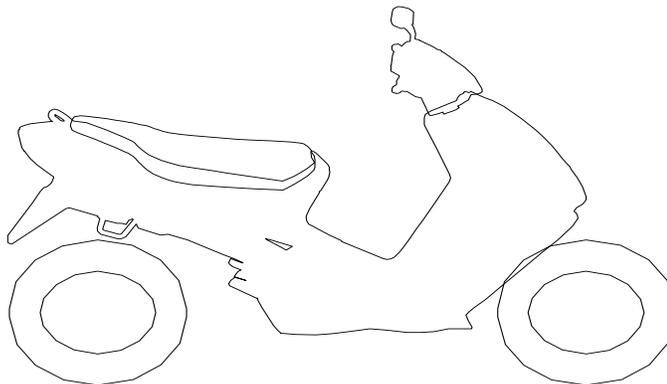
7. The condition of the Motorcycle's 2 tyres was observed to be in serviceable condition. The tread pattern of the 2 tyres was clearly visible. We did not observe any tear, burst mark(s) and/or punctured hole(s) on the sidewalls as well as across the tread of the 2 tyres. The 2 tyres were both observed to be sufficiently inflated for vehicular operation. The tyre brand, tyre size and remaining tread depth of the 2 tyres were recorded as follows:-

Trazano
80/90 - R17 (2mm)

Maxxis
70/90 - R17 (3mm)
