Your Ref: TP/IP/56239/2018
Our Ref :CI/TPD18022200/Z

08th February 2019

MECHANICAL INSPECTION REPORT OF MOTORCYCLE JPH 1866

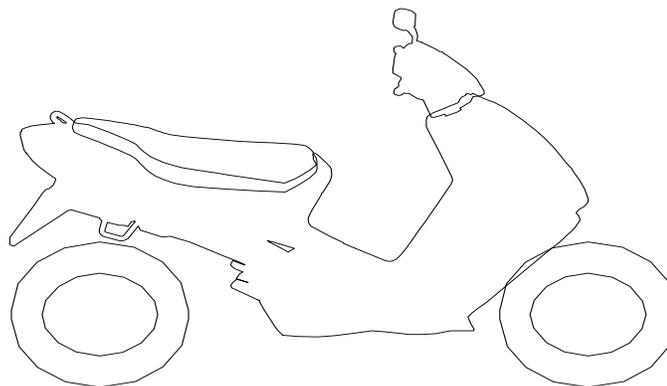
7. The condition of the Motorcycle's 2 tyres was observed to be in serviceable condition. The tread pattern of the 2 tyres was clearly visible. We did not observe any tear, burst mark(s) and/or punctured hole(s) on the sidewalls as well as across the tread of the 2 tyres. The 2 tyres were both observed to be sufficiently inflated for vehicular operation. The tyre brand, tyre size and remaining tread depth of the 2 tyres were recorded as follows:-

Trazano
80/90 - R17 (2mm)

Maxxis
70/90 - R17 (3mm)
