Your Ref: TP/IP/56239/2018
Our Ref : CI/TPD18022201/Z

07th March 2019

MECHANICAL INSPECTION REPORT OF MOTOR BUS PC 1706K

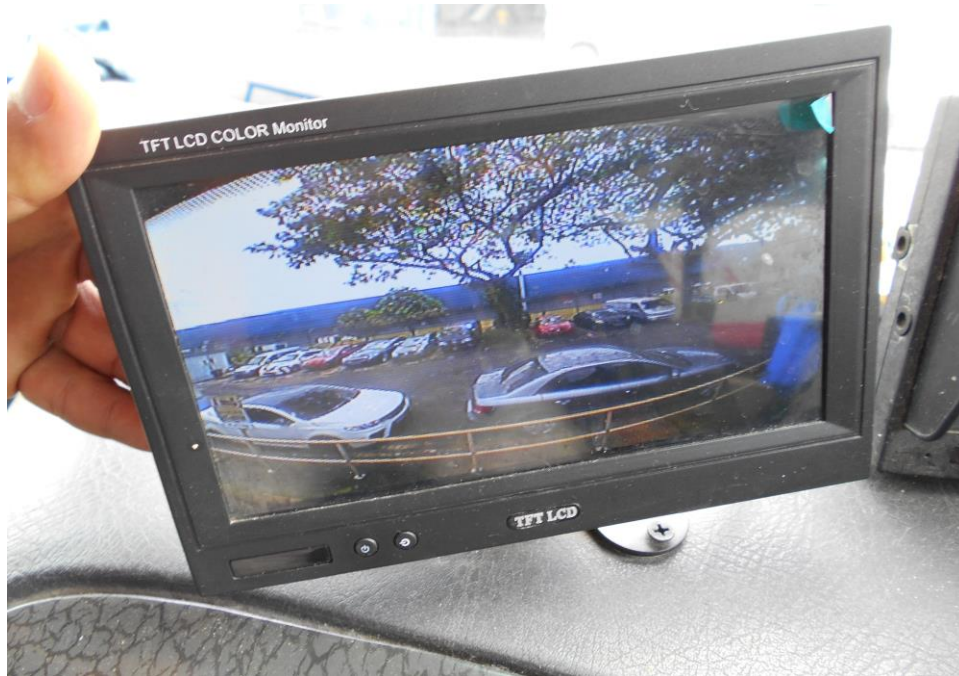
Photo 24 shows the reverse camera monitor which was installed in front the driver's seat for viewing rear portion while reversing the Motor Bus.
