Your Ref: TP/IP/59297/2018  
Our Ref : CI/TPD18022203/Z

**Fatal Accident Investigation Team**

**MECHANICAL INSPECTION REPORT OF MOTOR BUS CB 7364H.**

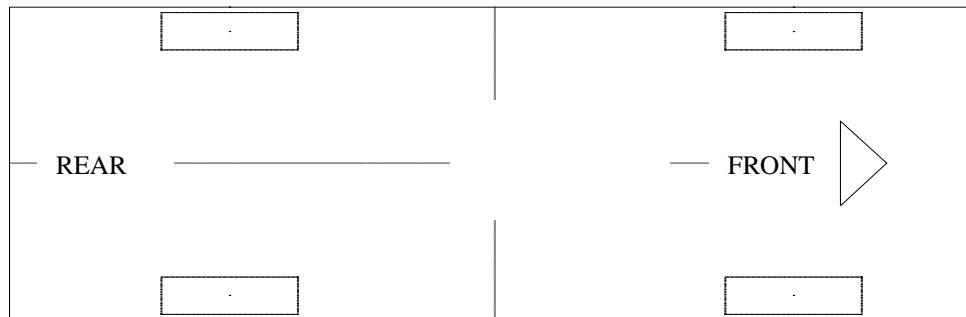
7. The 4 tyres were observed to be in serviceable condition and sufficiently inflated for vehicular operation. We did not find any tear, cut or burst mark(s) on the outer and the inner sidewalls as well as across the tread of the 4 tyres. The tyre brand, tyre size and remaining tread depth of the 6 tyres of the Motor Bus were recorded as follows:-

Bridgestone R623 195 R15C (6mm)

Bridgestone R623 195 R15C (8mm)

Bridgestone R623 195 R15C (7mm)
