Your Ref: TP/IP/58303/2018
Our Ref : CI/TPD18022205/Z

MECHANICAL INSPECTION REPORT OF MOTOR CAR SGK 2283X

1. We refer to your request on 28th November 2018 to conduct a physical inspection of a motor car bearing registration number SGK 2283X (herein referred to as “**Motor Car**”), which was involved in a fatal road traffic accident on 12th October 2018.
2. The purpose of this inspection is to primarily determine if there was any possible mechanical failure to the Motor Car that may have contributed to the accident.
3. Following the request, we carried out a physical inspection of the Motor Car on 19th December 2018 at the premises of Traffic Police vehicle pound, 517 Airport Road Singapore 539942. We now set out below our observations and comments with respect to this inspection.

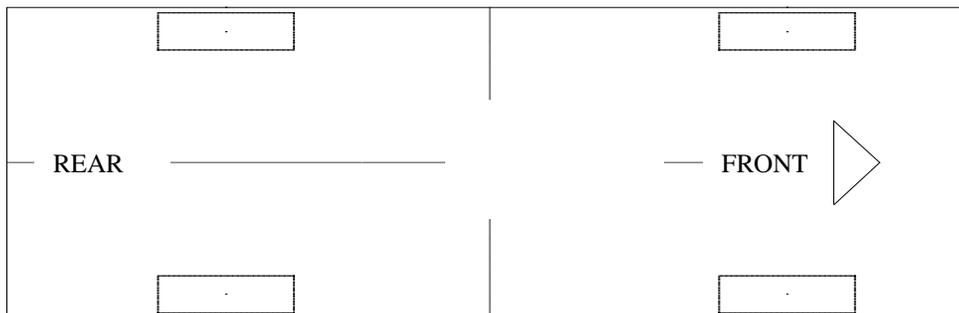
- The condition of the Motor Car's 4 tyres was observed to be in serviceable condition. We did not find any tear, cut or burst mark(s) on the outer and the inner sidewalls as well as across the tread of the 4 tyres. The 4 tyres were also observed to be sufficiently inflated for vehicular operation. The tyre brand, tyre size and remaining tread depth of the 4 tyres were recorded as follows:-

Yokohama BluEarth-A 175/65R14 (5mm)

Yokohama BluEarth-A 175/65R14 (6mm)

Maxtrek Maximus MI 175/65R14 (6mm)
