Your Ref: TP/IP/64375/2018
Our Ref : CI/TPD18022208/Z

Fatal Accident Investigation Team

MECHANICAL INSPECTION REPORT OF MOTOR BUS PC 5941X.

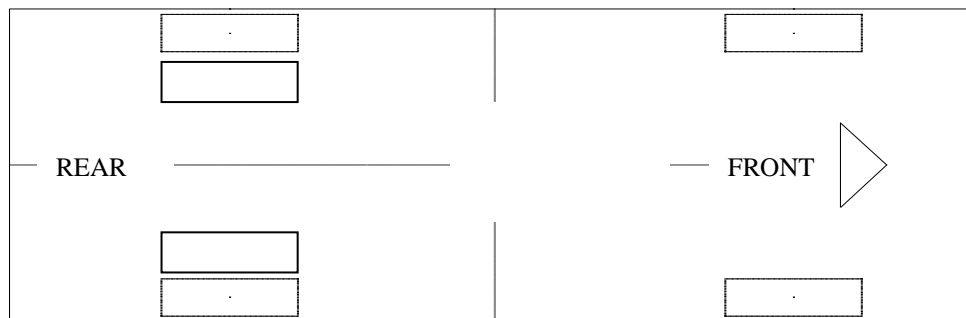
7. The 6 tyres were observed to be in serviceable condition and sufficiently inflated for vehicular operation. We did not find any tear, cut or burst mark(s) on the outer and the inner sidewalls as well as across the tread of the 6 tyres. The tyre brand, tyre size and remaining tread depth of the 6 tyres of the Motor Bus were recorded as follows:-

Bridgestone R202 205/85R16 (4mm)

Bridgestone R202 205/85R16 (8mm)

Bridgestone R202 205/85R16 (3mm)
