Your Ref: TP/IP/64127/2018  
Our Ref : CI/TPD18022211/P

26<sup>th</sup> April 2019

**Fatal Accident Investigation Team**

**MECHANICAL INSPECTION REPORT OF MOTOR LORRY YM 5867T**

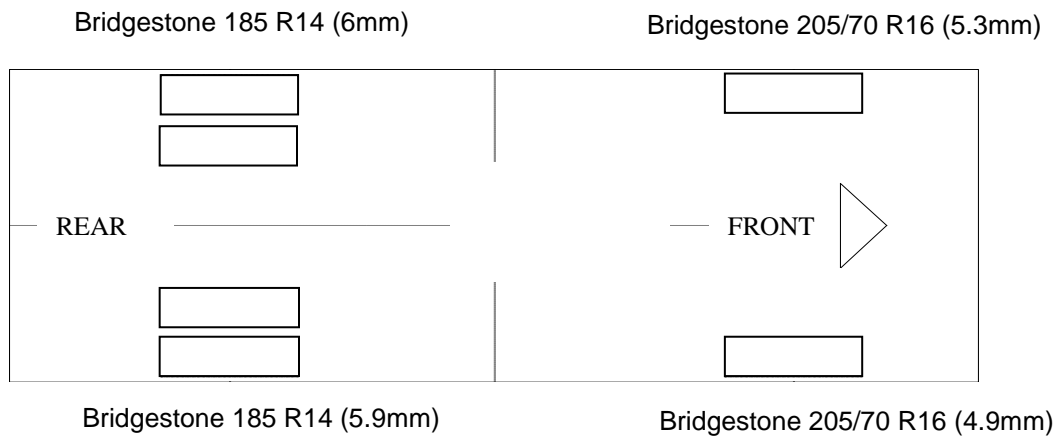
6. The 2 front tyres and 4 rear tyres of the Motor Lorry were observed to be in serviceable condition and sufficiently inflated for vehicular operation. I did not find any tear, cut or burst mark(s) on the outer and the inner sidewalls as well as across the tread of the 6 tyres. The tyre brand, tyre size and remaining tread depth of the 6 tyres of the Motor Lorry were recorded as follows:-
