Your Ref: TP/IP/56239/2018
Our Ref :CI/TPD18022215/Z

MECHANICAL INSPECTION REPORT OF MOTORCYCLE JSJ 8870

1. We refer to your request dated 28th November 2018 to conduct a physical inspection of a motorcycle bearing registration number JSJ 8870 (herein referred to as "**Motorcycle**"), which was involved in a fatal road traffic accident on 02nd October 2018.
2. The purpose of this inspection is to primarily determine if there was any possible mechanical failure to the Motorcycle that may have contributed to the accident.
3. Following the request, we had carried out a physical inspection of the Motorcycle on 21st December 2018 at the premises of Traffic Police vehicle pound, 517 Airport Road Singapore 539942. We now set out below our observations and comments with respect to this inspection.

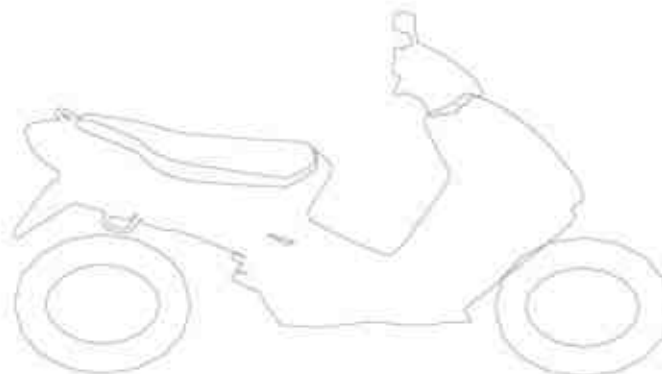
7. The condition of the Motorcycle's 2 tyres was observed to be in serviceable condition. The tread pattern of the 2 tyres was clearly visible. We did not observe any tear, burst mark(s) and/or punctured hole(s) on the sidewalls as well as across the tread of the 2 tyres. The 2 tyres were both observed to be sufficiently inflated for vehicular operation. The tyre brand, tyre size and remaining tread depth of the 2 tyres were recorded as follows:-

Vee Rubber
80/90 - R17 (4mm)

Vee Rubber
70/90 - R17 (4mm)
