Your Ref: TP/IP/60191/2018
Our Ref :CI/TPD18022476/Z

18th January 2019

MECHANICAL INSPECTION REPORT OF MOTORCYCLE FBC 9140E

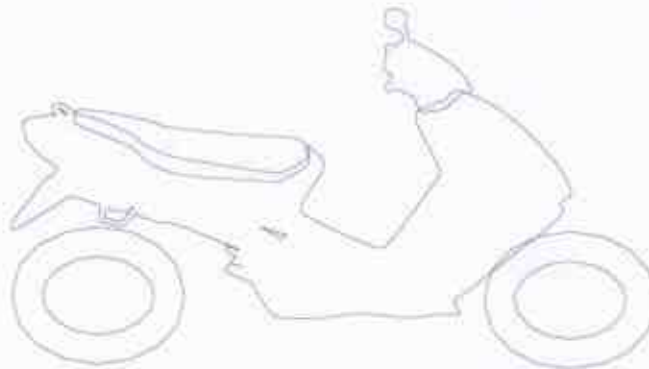
7. The condition of the Motorcycle's rear tyre was observed to be in serviceable condition. The tread pattern of the rear tyre was clearly visible. We did not observe any tear, burst mark(s) and/or punctured hole(s) on the sidewalls as well as across the tread of the rear tyre.
8. As for the front tyre it was found to be dislodged from the broken wheel rim likely due to the accident impact. However, the tread pattern of the front tyre was clearly visible. We did not observe any tear, burst mark(s) and/or punctured hole(s) on the sidewalls as well as across the tread of the front tyre. The tyre brand, tyre size and remaining tread depth of the 2 tyres were recorded as follows:-

Bridgestone 160/70 ZR 17(5mm)

Bridgestone 120/70 ZR 18(4mm)
