**Fatal Accident Investigation Team**

**MECHANICAL INSPECTION REPORT OF MOTORCYCLE JSC 3025**

1. We refer to your request dated 28<sup>th</sup> December 2018 to conduct a physical inspection of a motorcycle bearing registration number JSC 3025 (herein referred to as "**Motorcycle**"), which was involved in a fatal road traffic accident on 14<sup>th</sup> December 2018.
2. The purpose of this inspection is to primarily determine if there was any possible mechanical failure to the Motorcycle that may have contributed to the accident.
3. Following the request, we had carried out a physical inspection of the Motorcycle on 19<sup>th</sup> December 2019 at the premises of Traffic Police vehicle pound, 517 Airport Road Singapore 539942. We now set out below our observations and comments with respect to this inspection.

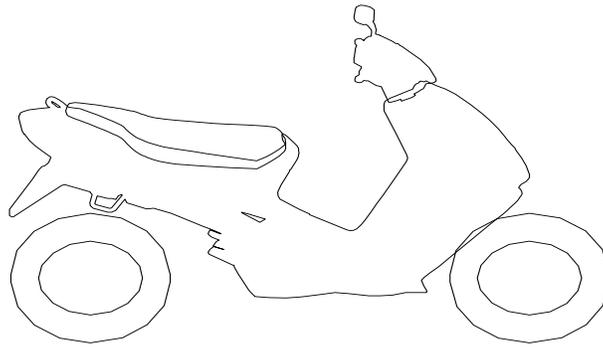
7. The condition of the Motorcycle's 2 tyres was observed to be in serviceable condition. The tread pattern of the 2 tyres was clearly visible. We did not observe any tear, burst mark(s) and/or punctured hole(s) on the sidewalls as well as across the tread of the 2 tyres. The 2 tyres were both observed to be sufficiently inflated for vehicular operation. The tyre brand, tyre size and remaining tread depth of the 2 tyres were recorded as follows:-

Metzeler 70/90 - R17 (2mm)

Vuelta Italia 70/90 - R17 (4mm)
