Your Ref: TP/IP/69185/2018
Our Ref :CI/TPD19000747/Z

26th March 2019

MECHANICAL INSPECTION REPORT OF MOTORCYCLE FBN 439X

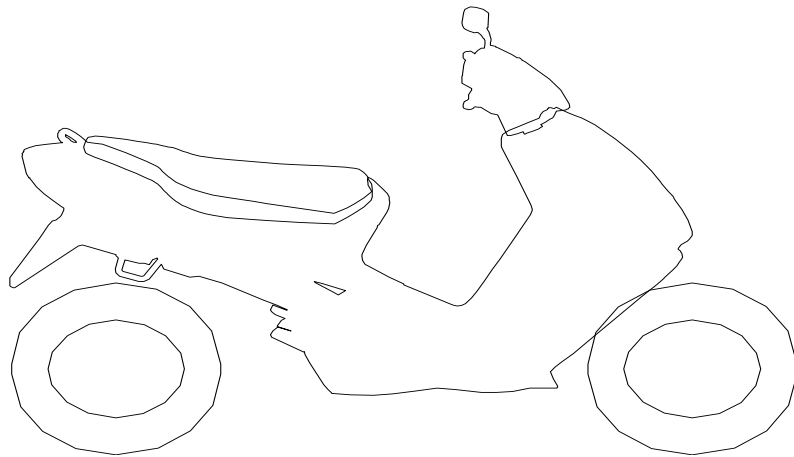
7. The condition of the Motorcycle's tyres was observed to be in serviceable condition. The tread pattern of the 2 tyres was clearly visible. We did not observe any tear, burst mark(s) and/or punctured hole(s) on the sidewalls as well as across the tread of the 2 tyres. Both tyres were observed to be sufficiently inflated for vehicular operation. The tyre brand, tyre size and remaining tread depth of the 2 tyres were recorded as follows:-

Kenda 180/90-15 (6mm)

Kenda 90/90-18 (5mm)
