Your Ref: TP/IP/68603/2018  
Our Ref: CI/TPD19000751/P

26<sup>th</sup> April 2019

**MECHANICAL INSPECTION REPORT OF MOTOR LORRY GBG 7101K**

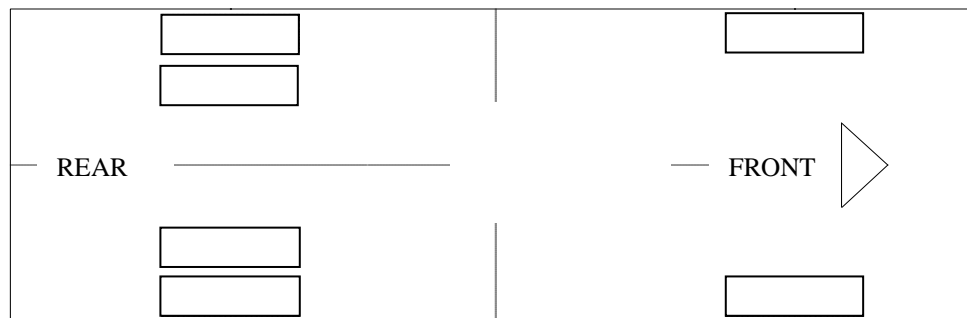
6. The 2 front tyres and 4 rear tyres of the Motor Lorry were observed to be in serviceable condition and sufficiently inflated for vehicular operation. We did not find any tear, cut or burst mark(s) on the outer and the inner sidewalls as well as across the tread of the 6 tyres. The tyre brand, tyre size and remaining tread depth of the 6 tyres of the Motor Lorry were recorded as follows:-

Dunlop155/R13 (4.4mm)

Leao 195/70 R15c (8.1mm)

Dunlop 155/R13 (3.4mm)

Leao 195/70 R15c (9.1mm)
