Your Ref: TP/IP/68603/2018
Our Ref: CI/TPD19000753/P

Fatal Accident Investigation Team

MECHANICAL INSPECTION REPORT OF MOTORCYCLE FBL 2650Z

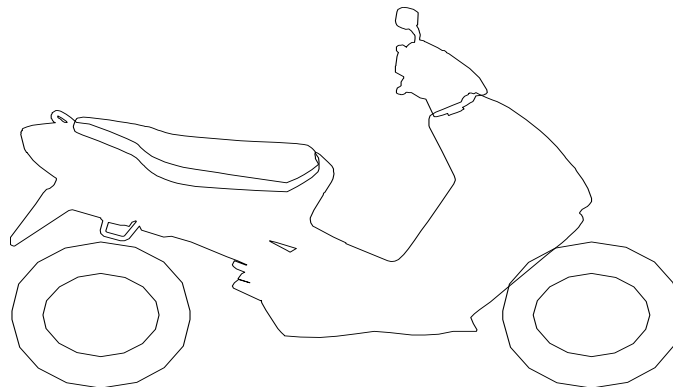
6. The condition of the Motorcycle's 2 tyres was observed to be in serviceable condition. The tread pattern of the 2 tyres was clearly visible. We did not observe any tear, burst mark(s) and/or punctured hole(s) on the sidewalls as well as across the tread of the 2 tyres. The 2 tyres were both observed to be sufficiently inflated for vehicular operation. The tyre brand, tyre size and remaining tread depth of the 2 tyres were recorded as follows:-

Zeneos
150/ 60 - 17 (4.4mm)

Zeneos
110/70 - 17 (6.5mm)
