Your Ref: TP/IP/69599/2018  
Our Ref :CI/TPD19000760/Z

**Fatal Accident Investigation Team**

**MECHANICAL INSPECTION REPORT OF MOTORCYCLE FBB 8612Y**

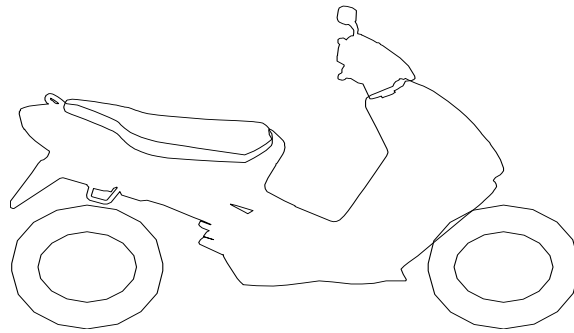
7. The condition of the Motorcycle's front tyre was observed to be in serviceable condition whereas the rear tyre was found to be deflated likely due to the accident impact. However, the tread pattern of the 2 tyres was clearly visible. We did not observe any tear, burst mark(s) and/or punctured hole(s) on the sidewalls as well as across the tread of the 2 tyres. The front tyre was observed to be sufficiently inflated for vehicular operation. The tyre brand, tyre size and remaining tread depth of the 2 tyres were recorded as follows:-

Bridgestone Battlax160/60 - 17 (4mm)-(Deflated)

Bridgestone Battlax120/60 - 17 (4mm)
