Your Ref: Honda Engine
(number B16A5205833)
Our Ref : CI/TP19002148/D

01 February 2019

INSPECTION REPORT OF A HONDA ENGINE WITH NUMBER B16A5205833

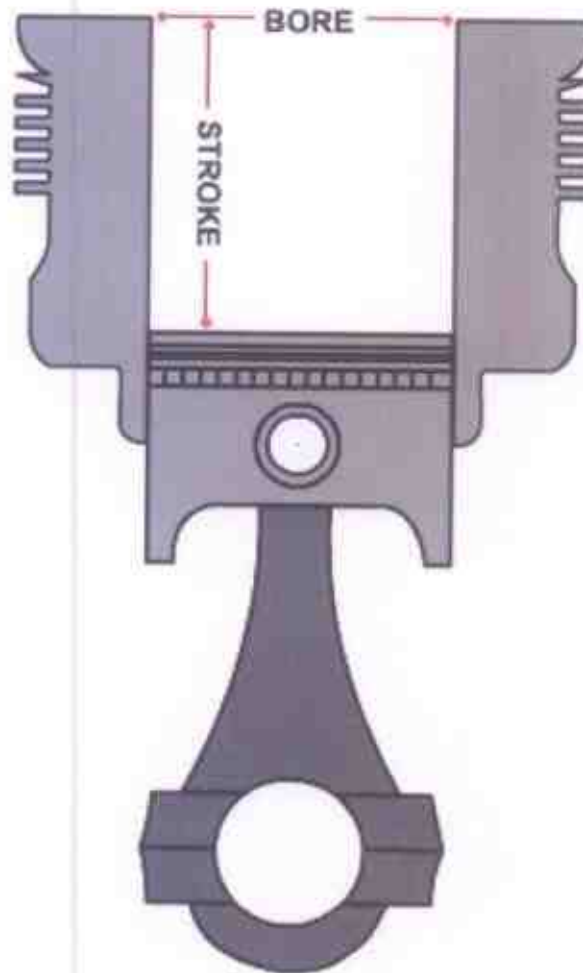
9. The bore of an engine refers to the measurement of the inside diameter of the cylinder while the stroke refers to the distance the piston moves in one direction of upward or downward movement in the cylinder. See diagram below for illustration purposes.
