Your Ref: 3963673214SG
Our Ref : CC3/AIG19002331/D

15 March 2019

**TECHNICAL INVESTIGATION REPORT OF FIRE INCIDENT INVOLVING THE
INSURED VEHICLE SKM 3566R ON 28 JANUARY 2019**

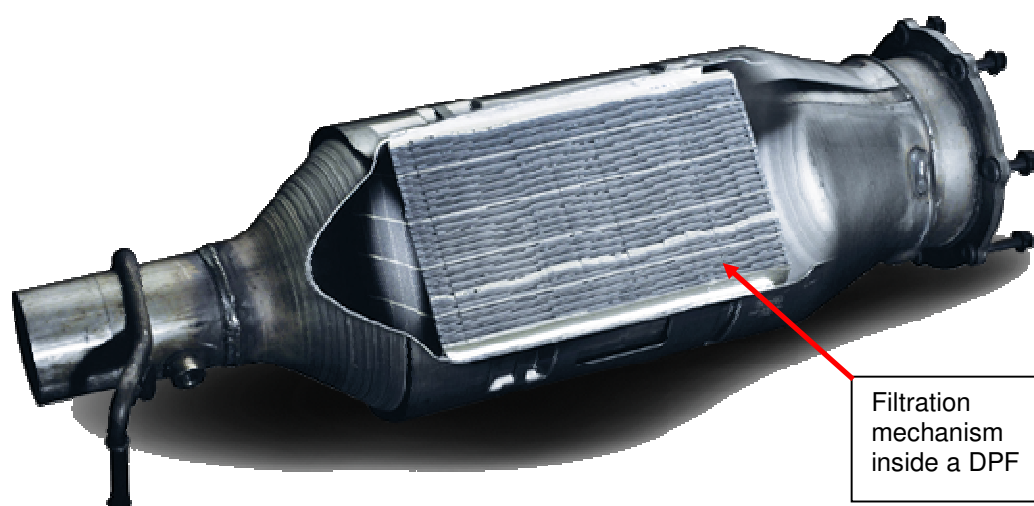
19. My research and ground investigation revealed that this model vehicle is fitted with a Diesel Particulate Filter (DPF). As with all modern-day diesel engine motor vehicles like the Insured Vehicle, DPF, a cannister like component (part), is fitted along the exhaust system of such type of motor vehicles. Briefly, DPF is a component (part) that captures diesel particulates through a combination of filtration mechanisms, preventing the diesel particulates from being release into the atmosphere as harmful gases. An illustration of a simple filtration mechanism inside a PDF is shown below.

20. Like all filter element, the filter element inside the DPF will begin to clog as soot (carbon) and other diesel particulate starts to accumulate on the filter element inside the DPF over a period of time. Cleaning of DPF is therefore required as part of its periodic maintenance. This is usually done through a process call "regeneration", when the exhaust temperature becomes high enough (usually at 600°C) to burn off the soot and other diesel particulate that have accumulated in the DPF. Driving a vehicle over long distance at speeds higher than road speeds allowed for urban city driving is the most common method of regenerating (cleaning) the DPF.

21. Smoke and/or fire from the underside of the vehicle or flames emanating from within the exhaust tailpipe can occur for such diesel engine vehicles when the exhaust temperature within the DPF increases due to clogging (exhaust gases becomes restricted and unable to flow out smoothly) or even when "regeneration" (cleaning). Heat from a fire within the DPF may possibly radiate to the surrounding vehicle components leading to heating of the vehicle underside, melting of interior components and in worst case, a potential interior fire. The DPF of the Insured Vehicle is located at the underside centre of the Insured Vehicle, below the centre console of the Insured Vehicle. This area was the area where smoke was seen emitting from the Insured Vehicle. The evidence gathered would then appear to indicate that the fire to the Insured Vehicle was a result of heat radiating from a fire that had occurred within the DPF that was fitted at the underside centre of the Insured Vehicle.
