Your Ref: 583341
Our Ref : CS/MSG19002385/N

**TECHNICAL INVESTIGATION REPORT OF FIRE INCIDENT INVOLVING THE
MOTOR VEHICLE WC 4290P ON 24 JANUARY 2019**

Vehicle Registration No.	: WC 4290P
Make / Model	: NISSAN CGB45CLSMNB
Chassis No	: CGB4CLS00197
Year of Registration	: June 2011
Mileage	: N.A (wiring affected)

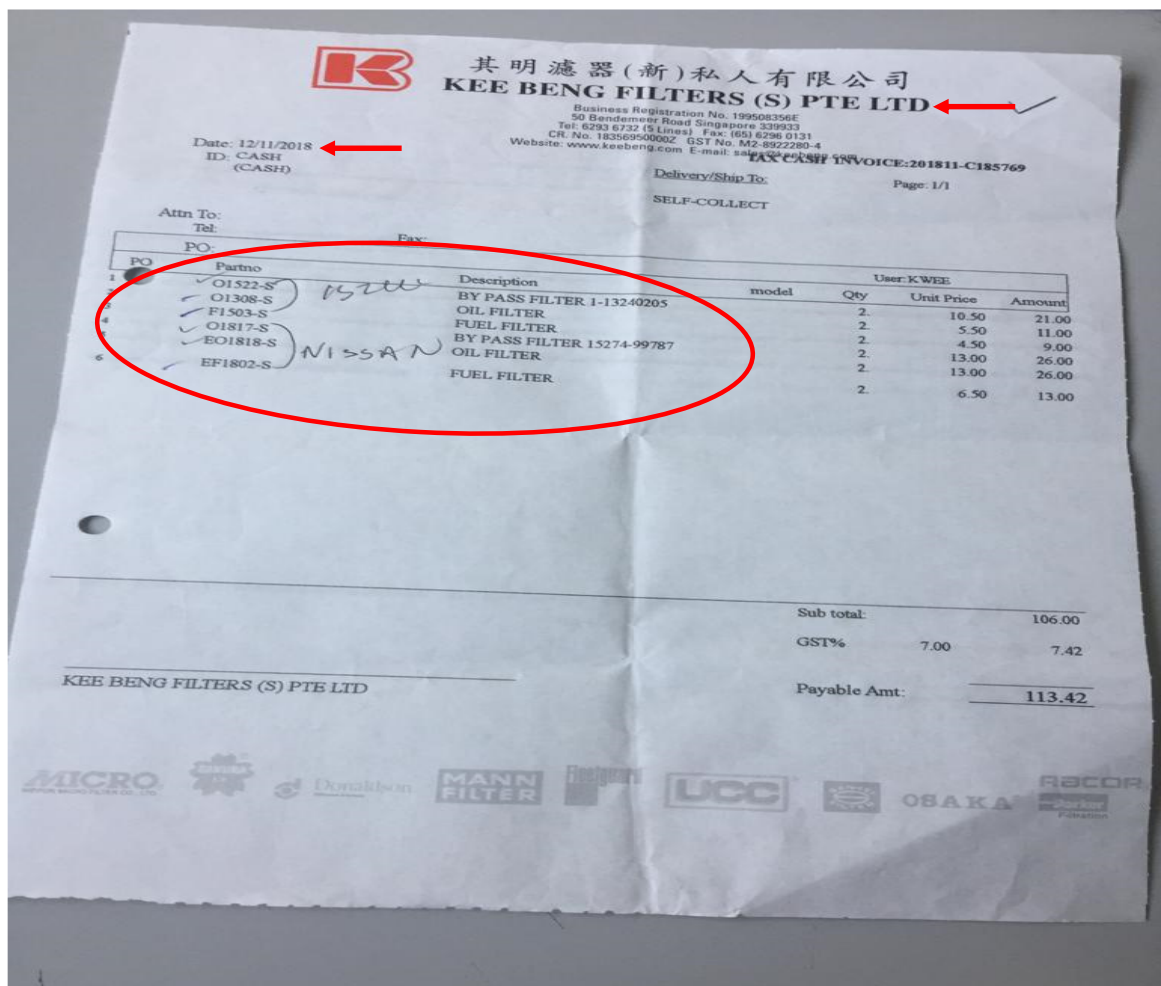
15. Pertaining to the maintenance aspect, Mr Siva informed us that the Insured Vehicle was serviced periodically every 3 to 4 months. The vehicle servicing is done in- house. Mr Siva purchases the parts separately. He purchased the bypass, oil and fuel filters from Kee Beng Filters (S) Pte. Ltd. on 12 November 2018. He purchased the engine oil from Gee Boon Enterprises on 3 December 2018. The Insured Vehicle was last serviced on 15 December 2018.
16. The gearbox drum parts were purchased from Kian Ho Pte. Ltd. on 21 January 2019.
17. During the course of our investigations, we were able to obtain from Mr Siva the copies of the parts he purchased for the servicing as well as for the repair of the Insured Vehicle's cement drum gearbox. See invoices 1 - 3 below.

21. Based on the vehicle service record invoices provided, we are of the opinion that it is unlikely that the fire could have been caused by poor maintenance of the Insured Vehicle. Furthermore, the Insured Vehicle was not utilised 2 weeks prior to the incident.

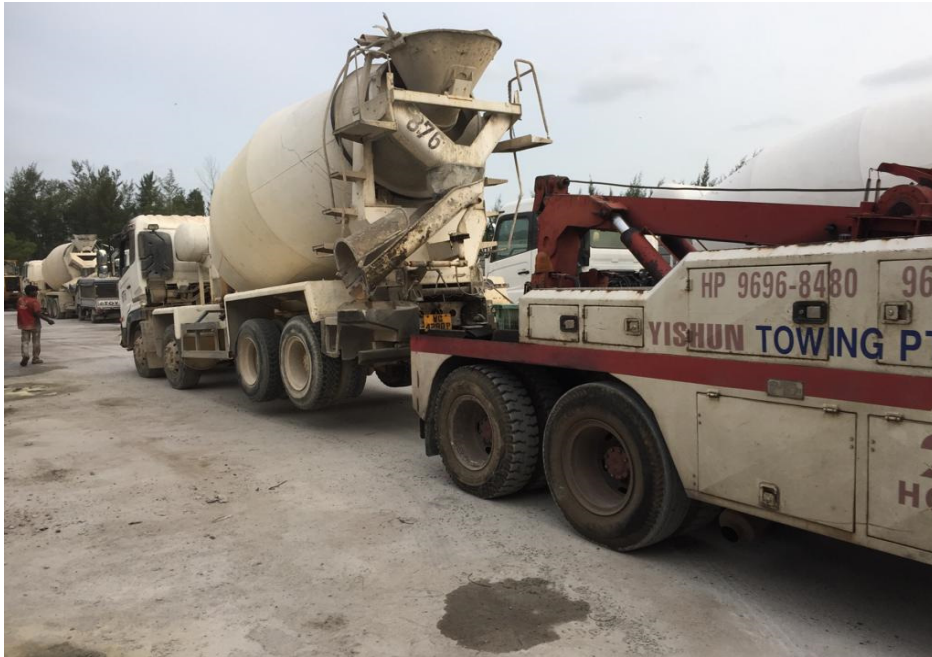
Photo 13 shows the Insured Vehicle being prepped to be towed away to Tan Chong.
