Your Ref: TP/IP/53269/2018
Our Ref : CI/TPD19002512/Z

Fatal Accident Investigation Team

MECHANICAL INSPECTION REPORT OF MOTOR TAXI SHD 9754H

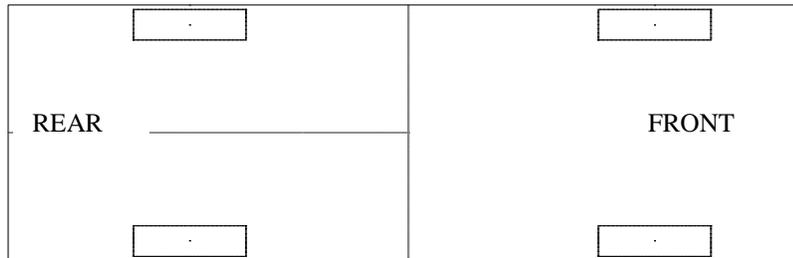
7. The condition of the Motor Taxi's 4 tyres was observed to be in serviceable condition. We did not find any tear, cut or burst mark(s) on the outer and the inner sidewalls as well as across the tread of the 4 tyres. The 4 tyres were also observed to be sufficiently inflated for vehicular operation. The tyre brand, tyre size and remaining tread depth of the 4 tyres were recorded as follows:-

Giti Comfort T20 215/60R16 (7mm)

Giti Comfort T20 215/60R16 (6mm)

Ling Long CrossWing 215/60R16 (7mm)
