MECHANICAL INSPECTION REPORT OF MOTOR TAXI SHA 8661P

1. We refer to your request on 1 February 2019 to conduct a physical inspection of a motor taxi bearing registration number SHA 8661P (herein referred to as "**Motor Taxi**"), which was involved in a fatal road traffic accident on 5 December 2018.
2. The objective of the inspection is to determine if there was any possible mechanical failure to the Motor Taxi that may have contributed to the accident.
3. Following the request, we had carried out a physical inspection of the Motor Taxi on 2 May 2019 at the premises of Traffic Police vehicle pound, 517 Airport Road Singapore 539942. We now set out below our observations and comments with respect to this inspection.

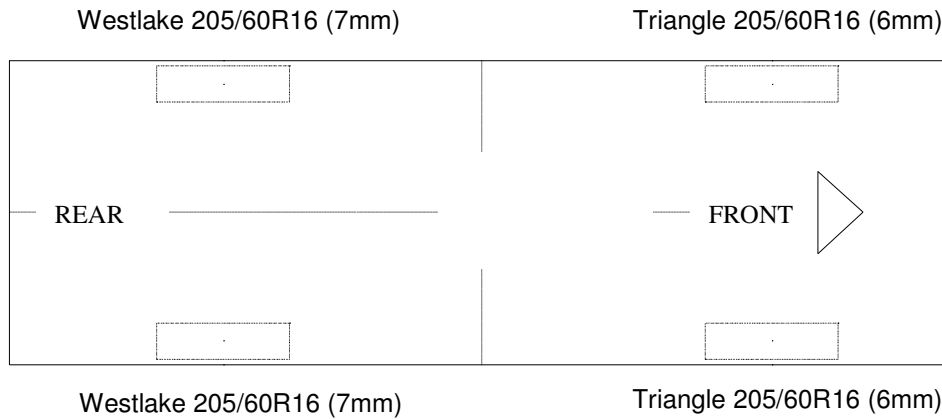
6. The condition of the Motor Taxi's 4 tyres was observed to be in serviceable condition. We did not find any tear, cut or burst mark(s) on the outer and the inner sidewalls as well as across the tread of the 4 tyres. The 4 tyres were also observed to be sufficiently inflated for vehicular operation. The tyre brand, tyre size and remaining tread depth of the 4 tyres were recorded as follows:-
