Your Ref: TP/IP/66301/2018
Our Ref : CI/TPD19002521/P

17th May 2019

MECHANICAL INSPECTION REPORT OF MOTOR CAR SJH 9201S

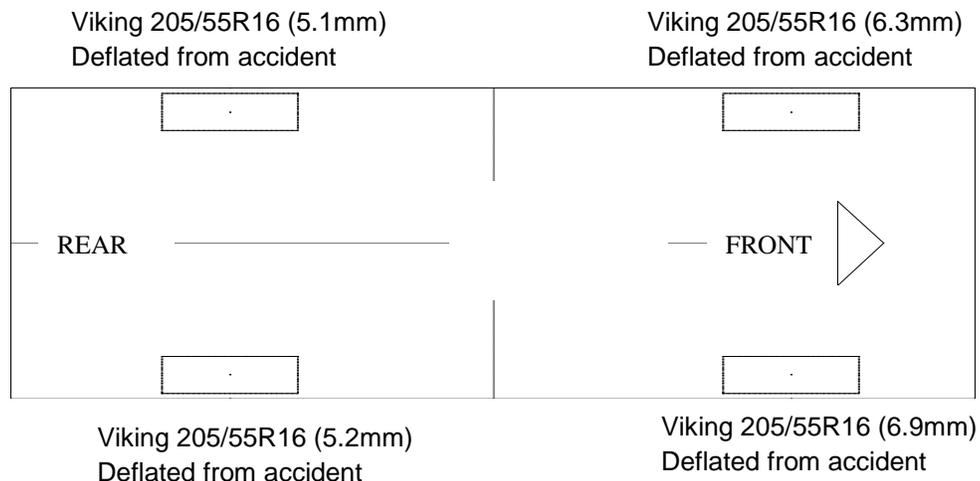
7. The condition of the Motor car's 4 tyres was observed to be in serviceable condition. I did not find any tear, cut or burst mark(s) on the outer and the inner sidewalls as well as across the tread of the 4 tyres. The 4 tyres were also observed to be sufficiently inflated for vehicular operation. The tyre brand, tyre size and remaining tread depth of the 4 tyres were recorded as follows:-

8. The 4 tyres were observed to be deflated due to damage to the rims. I did not find any tear, cut or burst mark(s) on the outer and the inner sidewalls as well as across the tread of the 4 tyres. The remaining tread depth of the 4 tyres was approximately 5.1 – 6.9mm.
