Your Ref: BMW 523i  
(chassis number WBAJL120X0BE46952)  
Our Ref : CI/TP19003398/D

23 February 2019

**INSPECTION REPORT OF AN UNREGISTERD BMW 523i MOTOR CAR WITH CHASSIS NUMBER WBAJL120X0BE46952**

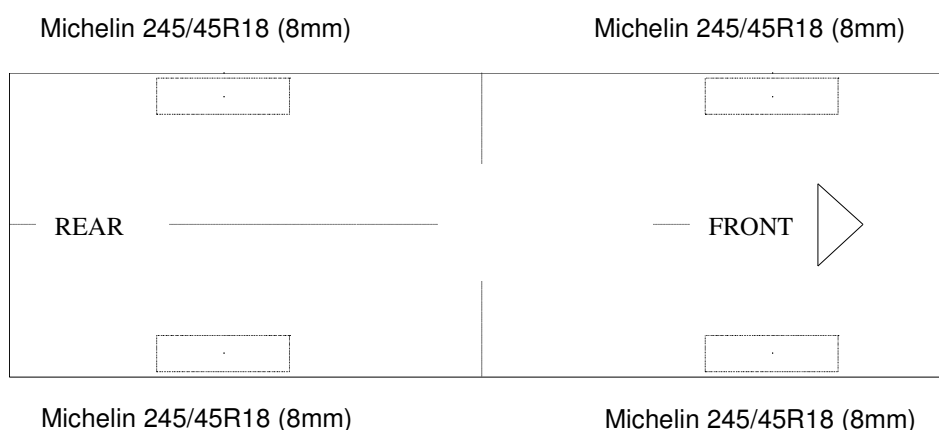
6. It was fitted with 18inch sport wheel rims that were wrapped with tyres that were observed to be of serviceable condition. The tyres were also sufficiently inflated for vehicular operation. The tyre brand, tyre size and approximate remaining tread depth of the 4 tyres of the Motor Car were recorded as follows: -
