Your Ref: TP/IP/01847/2019  
Our Ref : CI/TPD19004300/P

**Accident Enquiry & Investigation Team**

**MECHANICAL INSPECTION REPORT OF MOTOR CAR SCK 1726P**

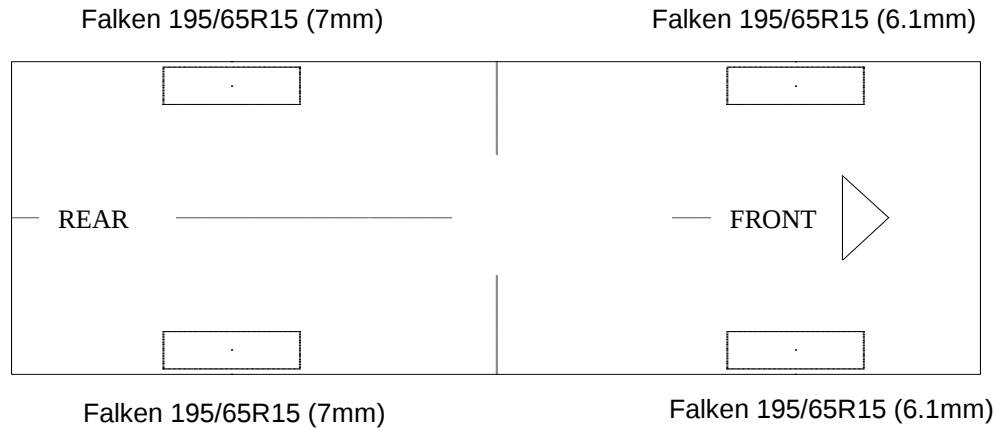
6. The condition of the Motor car's 4 tyres was observed to be in serviceable condition. I did not find any tear, cut or burst mark(s) on the outer and the inner sidewalls as well as across the tread of the 4 tyres. The 4 tyres were also observed to be sufficiently inflated for vehicular operation. The tyre brand, tyre size and remaining tread depth of the 4 tyres were recorded as follows:-
