Your Ref: TP/IP/03829/2019  
Our Ref : CI/TPD19004305/P

### **Fatal Accident Investigation Team**

### **MECHANICAL INSPECTION REPORT OF MOTOR LORRY XD 3396H**

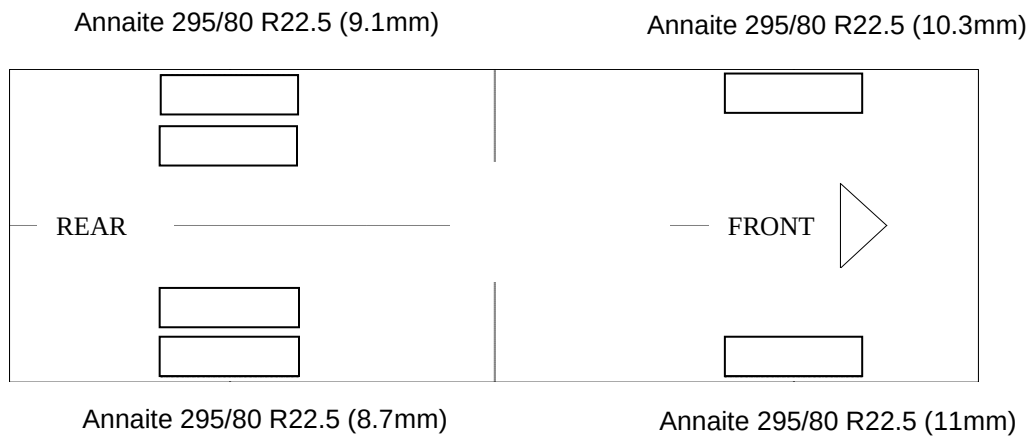
6. The 2 front tyres and 4 rear tyres of the Motor Lorry were observed to be in serviceable condition and sufficiently inflated for vehicular operation. I did not find any tear, cut or burst mark(s) on the outer and the inner sidewalls as well as across the tread of the 6 tyres. The tyre brand, tyre size and remaining tread depth of the 6 tyres of the Motor Lorry were recorded as follows:-
