Your Ref: 2473355709SG
Our Ref : CI/AIG19004979/D

**TECHNICAL INVESTIGATION REPORT OF FIRE INCIDENT INVOLVING THE
INSURED VEHICLE SLJ 3671Z ON 30 JANUARY 2019**

Vehicle Registration No.	: SLJ 3671Z
Make / Model	: Jaguar XJ 3.0L Diesel
Chassis No	: SAJAC2229ANV09855
Year of Registration	: 2010 (September)
Mileage	: N.A (wiring affected)

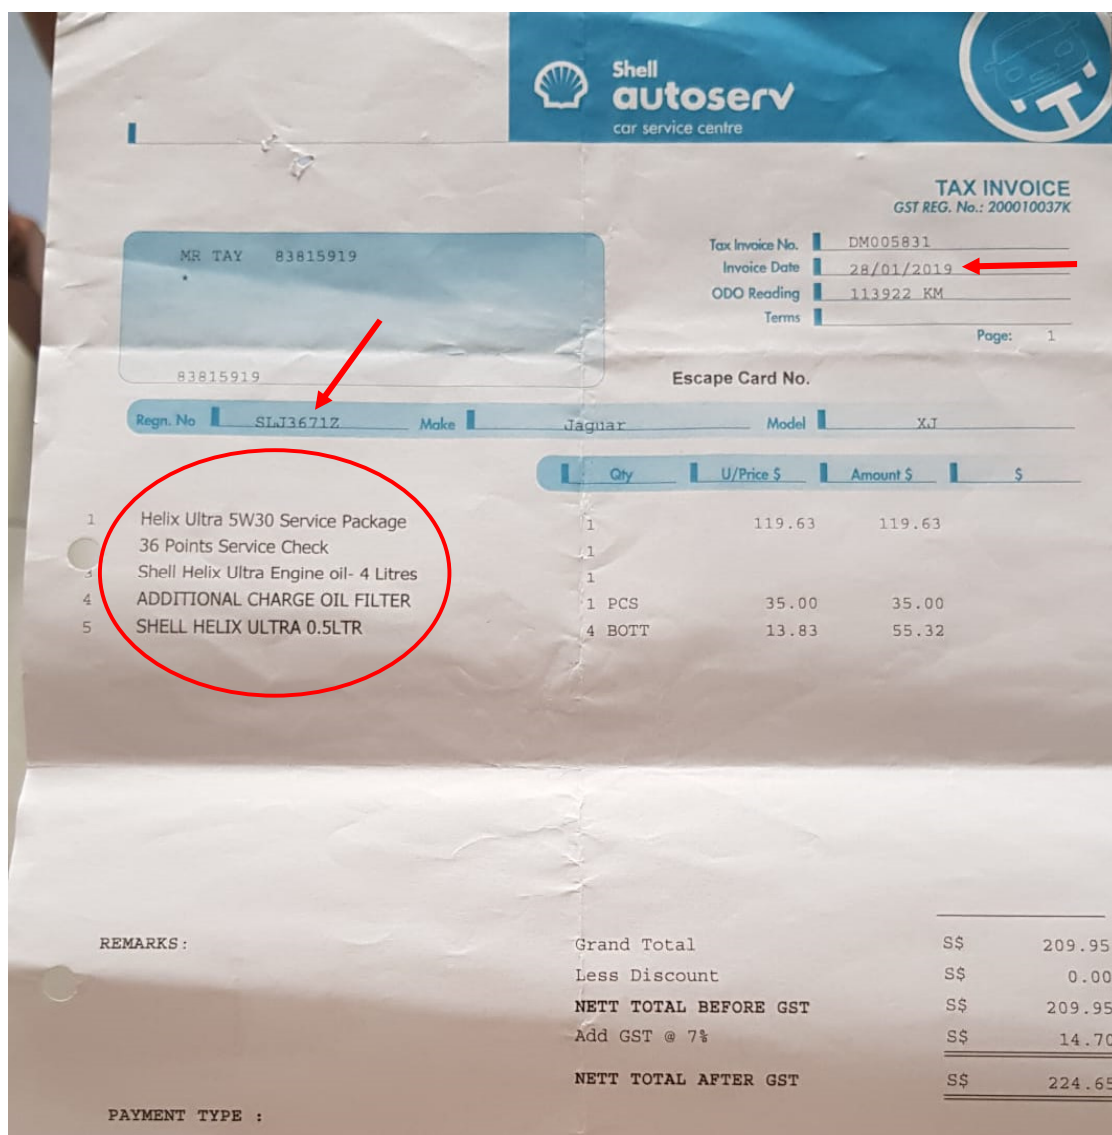
16. My review of the document provided by Mr Tay relating to the servicing of the Insured Vehicle revealed that the Insured Vehicle was last serviced on 28 January 2018, which was 2 days before this fire incident. The mileage of the Insured Vehicle was recorded as 113,922km. It was also noted that a standard service was carried out to the Insured Vehicle where the engine oil and engine oil filter were replaced. See photo 8 below showing the document that was provided by Mr Tay.

Photo 8 shows the document relating to the servicing of the Insured Vehicle that was carried out 2 days prior to the fire incident. A standard service was carried out to the Insured Vehicle where the engine oil and engine oil filter were replaced.

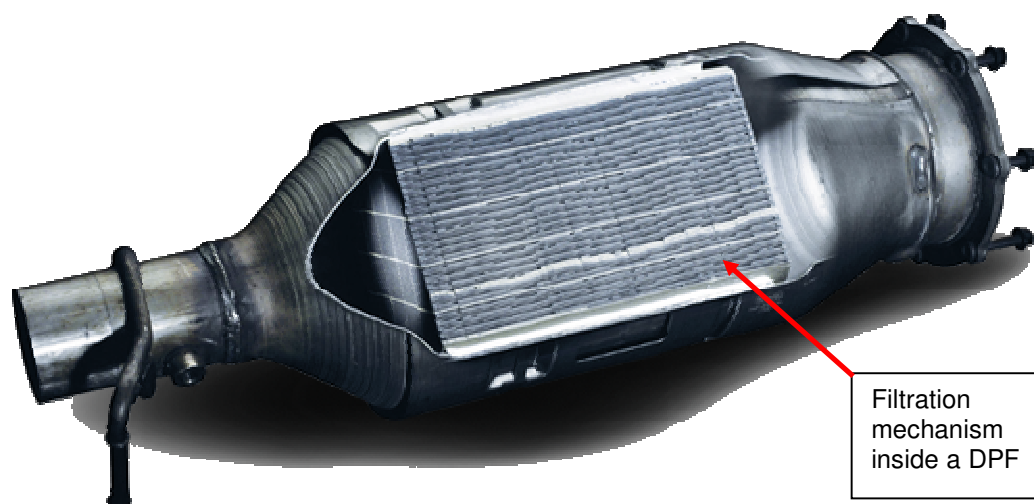
18. According to Mr Tay, after alighting from the Insured Vehicle, he saw flames at the underside of the Insured Vehicle; and before the fire, the yellow DPF light had illuminated on the instrument panel. My research and ground investigation revealed that this model vehicle is fitted with a Diesel Particulate Filter (DPF). As with all modern-day diesel engine motor vehicles like the Insured Vehicle, DPF, a cannister like component (part), is fitted along the exhaust system of such type of motor vehicles. Briefly, DPF is a component (part) that captures diesel particulates through a combination of filtration mechanisms, preventing the diesel particulates from being release into the atmosphere as harmful gases. An illustration of a simple filtration mechanism inside a PDF is shown below.

19. Like all filter element, the filter element inside the DPF will begin to clog as soot (carbon) and other diesel particulate starts to accumulate on the filter element inside the DPF over a period of time. Cleaning of DPF is therefore necessary as part of its periodic maintenance. This is usually done through a process call "regeneration", when the exhaust temperature becomes high enough (usually at 600°C) to burn off the soot and other diesel particulate that have accumulated in the DPF. Driving a vehicle over long distance at speeds higher than road speeds allowed for urban city driving is the most common method of regenerating (cleaning) the DPF.

20. Smoke and/or fire from the underside of the vehicle or flames emanating from within the exhaust tailpipe can occur for such diesel engine vehicles when the exhaust temperature within the DPF increases due to clogging (exhaust gases becomes restricted and unable to flow out smoothly) or even when “regeneration” (cleaning). Heat from a fire within the DPF may possibly radiate to the surrounding vehicle components leading to heating of the vehicle underside, melting of interior components and in worst case, a potential interior fire.

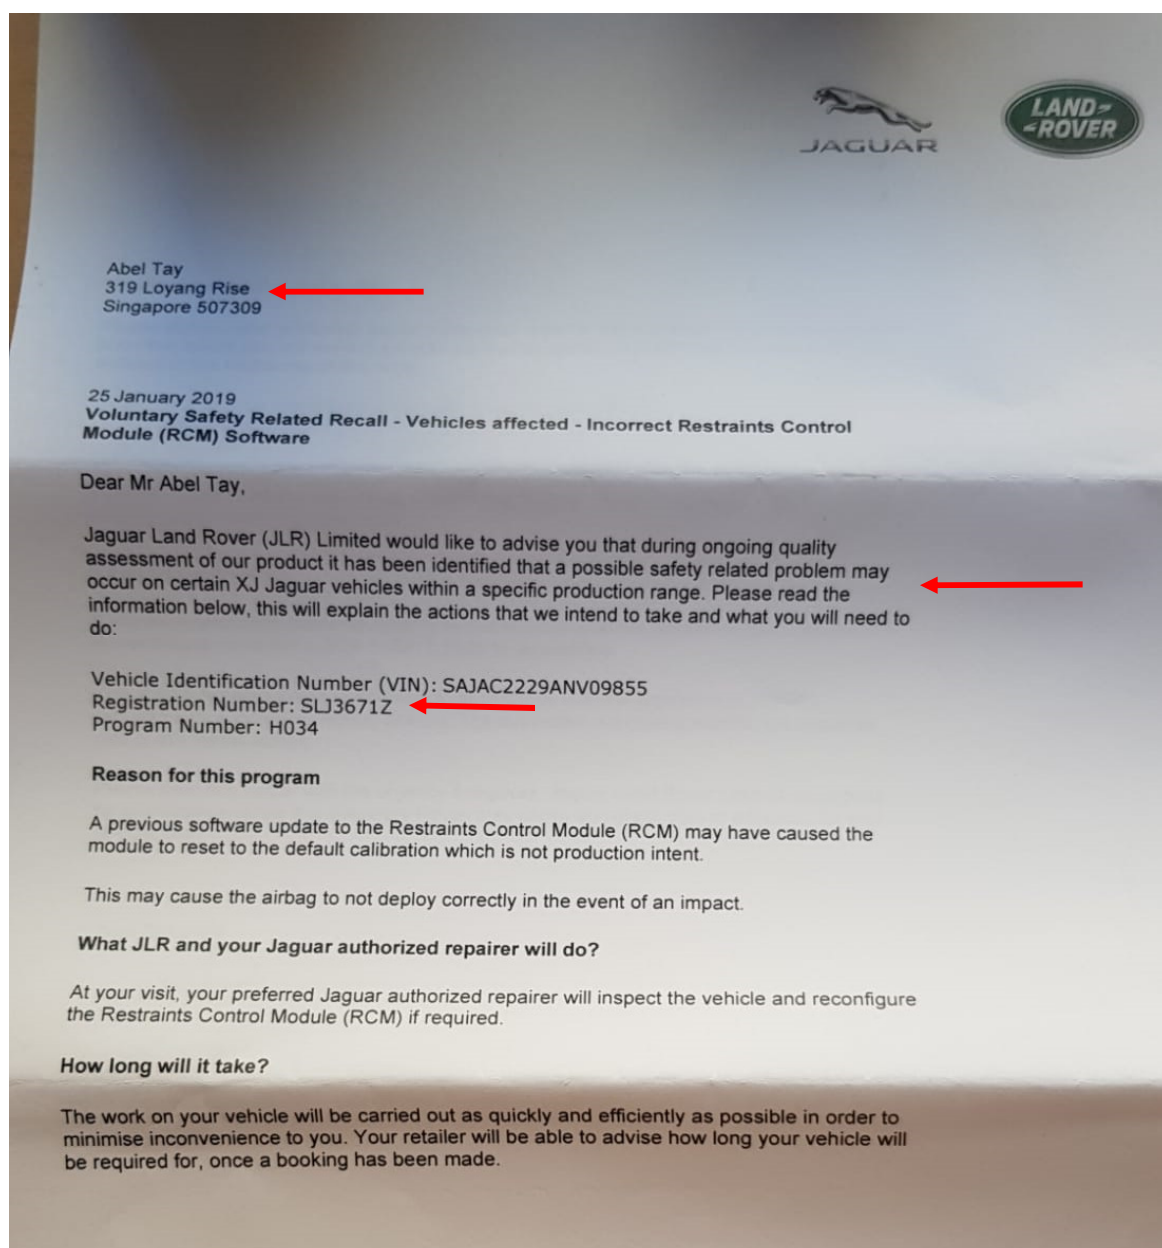
23. From my investigations, a manufacturer recall campaign involving the Insured Vehicle was initiated in 2017. The recall was for software issue to the control module of the restraint system (airbags, seatbelts etc). From the records, the Insured Vehicle has yet to be sent for rectification to address the purpose of the recall. Mr Tay also confirmed that he received a letter from Wearnes Automotive Pte Ltd informing him of this issue. See photo 11 showing the letter addressed to Mr Tay.

Photo 11 shows the letter that Mr Tay received pertaining to the software issue to the control module of the restraint system (airbags, seatbelts etc). The Insured Vehicle has yet to be sent for rectification to address the purpose of the recall.
