PRE-REPAIR SURVEY REPORT

NTUC Income Insurance Co-operative Ltd

Assign Date:	05/10/2017	Survey Date:	05/10/2017	Our Ref:	AVS2017-12734/WH
Accident Date:	30/09/2017	TP Policy No:	TBA	Your Ref:	MT/0963605-002
Place of Survey:	Eng Soon Painting Services 3998 Woodlands Rd, Yew Tee Ind Est Singapore 678035	Claim Type:	Third Party

Veh. No:	FBE6658M	Make/Model:	Yamaha T135
Colour:	Yellow	Engine No:	5YP302747
Engine Capacity:	135cc	Chassis No:	5YP302747
Odometer:	71554	Reg. Date:	2010

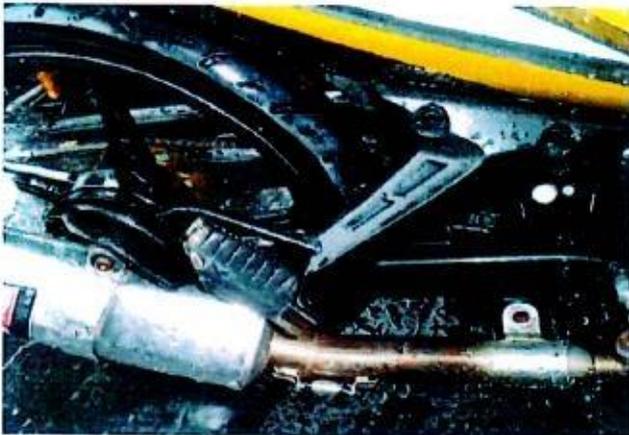
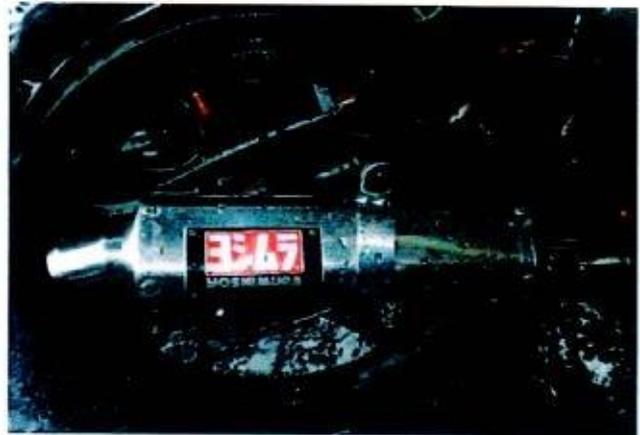
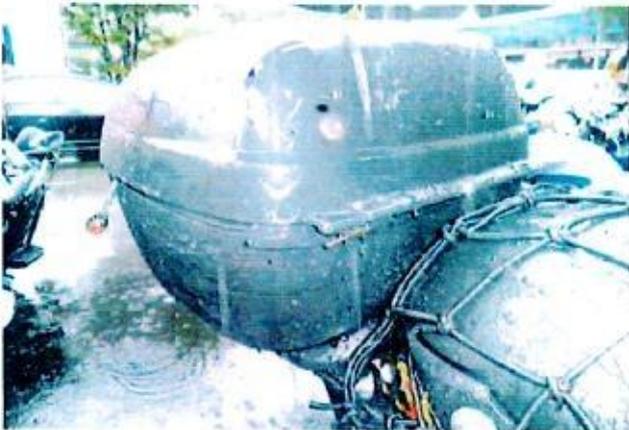
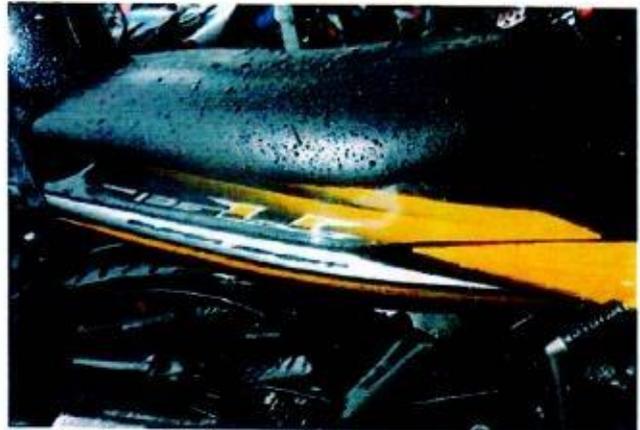
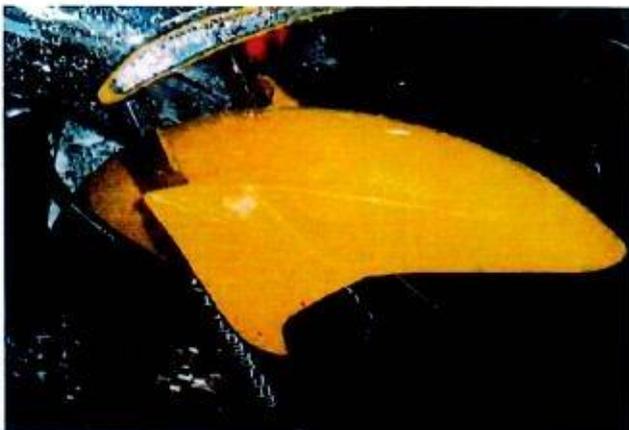
Pre-repair survey

The vehicle sustained damage on the left portion.

The rear box, exhaust pipe, front fairing, handle bar, clutch lever, brake lever and front mudguard were among the items affected.

Our recommended amount for the cost of contract lumpsum repair is S\$1,800.00 with approximately four (4) working days to complete. However, no finalisation was agreed with the repairer.
