Your Ref: TP/IP/21525/2019
Our Ref : CI/TPD19008246/P

03rd June 2019

MECHANICAL INSPECTION REPORT OF MOTOR TAXI SHB 8760G

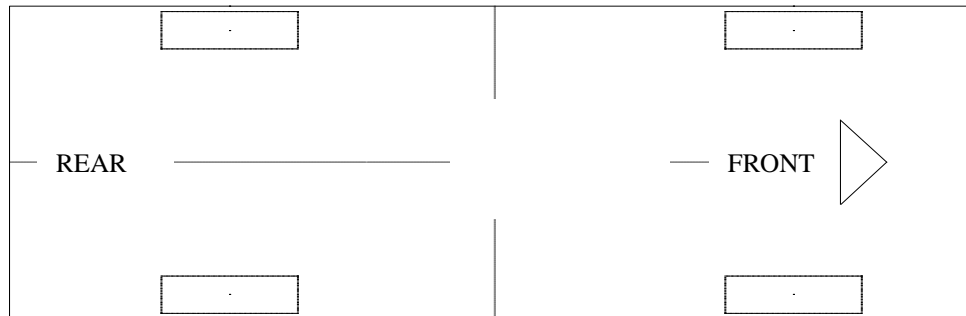
6. The condition of the Motor Taxi's 4 tyres was observed to be in serviceable condition. The 4 tyres were also sufficiently inflated for vehicular operation. I did not find any tear, cut or burst mark(s) on the outer and the inner sidewalls as well as across the tread of the 4 tyres. The tyre brand, tyre size and remaining tread depth of the 4 tyres were recorded as follows:-

Hankook 205/65R16 (6.7mm)

Hankook 205/65R16 (7.8mm)

Hankook 205/65R16 (6.8mm)
