Your Ref: TP/IP/012567/2019  
Our Ref : CI/TPD19008254/P

**Fatal Accident Investigation Team**

**MECHANICAL INSPECTION REPORT OF MOTOR TAXI SHD 6208M**

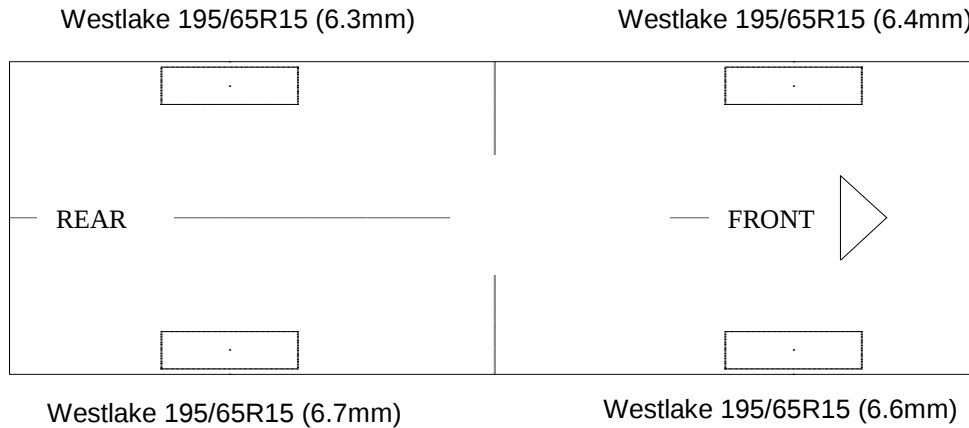
6. The condition of the Motor Taxi's 4 tyres was observed to be in serviceable condition. I did not find any tear, cut or burst mark(s) on the outer and the inner sidewalls as well as across the tread of the 4 tyres. The 4 tyres were also observed to be sufficiently inflated for vehicular operation. The tyre brand, tyre size and remaining tread depth of the 4 tyres were recorded as follows:-
