Your Ref: TP/IP/019355/2019
Our Ref : CI/TPD19008260/P

Fatal Accident Investigation Team

MECHANICAL INSPECTION REPORT OF MOTOR TAXI SHC 4495T

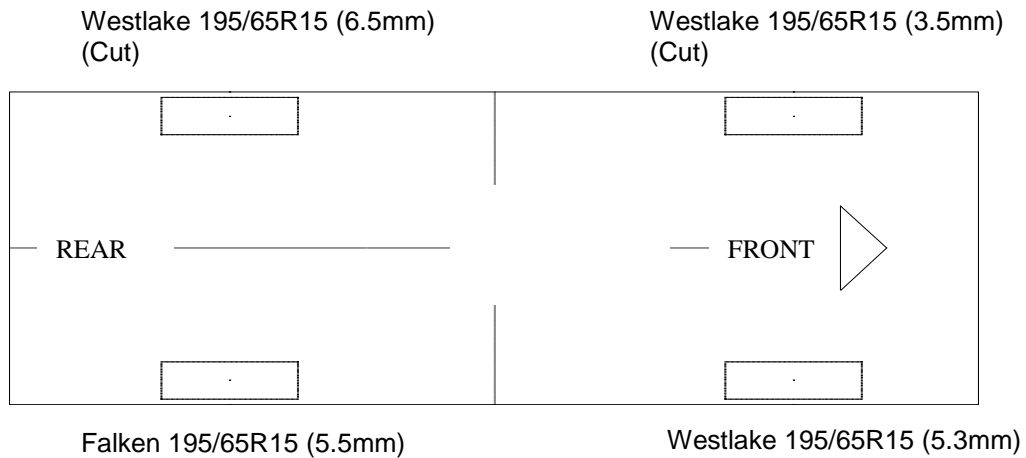
6. The condition of the Motor Taxi's tyres was observed, the left front and rear tyres we observed to have been cut and deflated as a result of the accident; however the other two tyres found to be in serviceable condition. I did not find any tear, cut or burst mark(s) on the outer and the inner sidewalls as well as across the tread of the 2 tyres. The 2 tyres were also observed to be sufficiently inflated for vehicular operation. The tyre brand, tyre size and remaining tread depth of the 4 tyres were recorded as follows: -
