Your Ref: TP/IP/06699/2019
Our Ref : CI/TPD19008264/P

General Investigation Team A

MECHANICAL INSPECTION REPORT OF MOTOR CAR SLX 4768Z

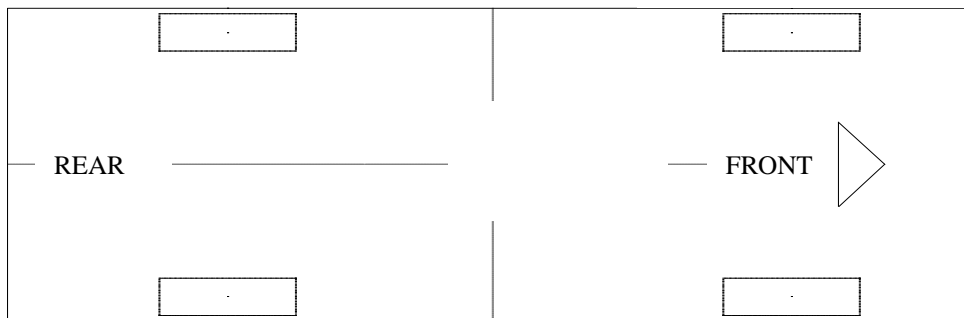
7. The condition of the Motor Car's 4 tyres was observed to be in serviceable condition. I did not find any tear, cut or burst mark(s) on the outer and the inner sidewalls as well as across the tread of the 4 tyres. The 4 tyres were also observed to be sufficiently inflated for vehicular operation. The tyre brand, tyre size and remaining tread depth of the 4 tyres were recorded as follows:-

Toyo 205/60R16 (5.1mm)

Toyo 205/60R16 (6.4mm)

Toyo 205/60R16 (5.9mm)

Toyo 205/60R16 (6.9mm)
