Your Ref: TP/IP/10579/2019
Our Ref : CI/TPD19008270/P

25th July 2019

MECHANICAL INSPECTION REPORT OF MOTOR BUS SBS 7637T

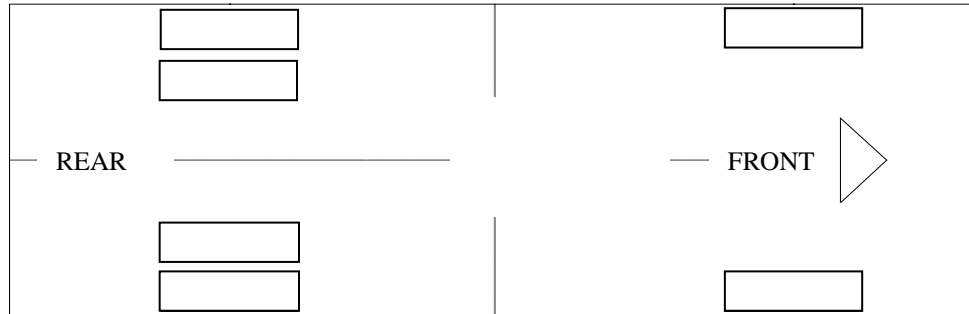
6. The 2 front tyres and 4 rear tyres of the Motor Bus were observed to be in serviceable condition and sufficiently inflated for vehicular operation. I did not find any tear, cut or burst mark(s) on the outer and the inner sidewalls as well as across the tread of the 6 tyres. The tyre brand, tyre size and remaining tread depth of the 6 tyres of the Motor Bus were recorded as follows:-

Bridgestone 275/70R22.5 (6.4mm)

Bridgestone 275/70R22.5 (8.6mm)

Bridgestone 275/70R22.5 (6.6mm)

Bridgestone 275/70R22.5 (10.2mm)
