Your Ref: TP/IP/13095/2019
Our Ref : CI/TPD19008282/P

Fatal accident Investigation Team

MECHANICAL INSPECTION REPORT OF MOTOR CAR SJQ 5827R

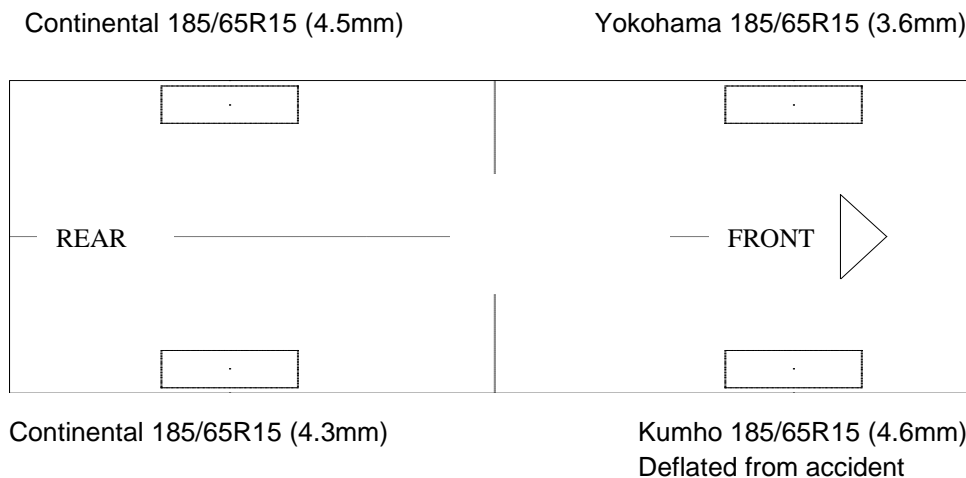
9. All 4 tyres of the Motor Car were wrapped around steel wheel rims. The front left wheel rim found to be slightly dented however, the front right wheel rim, rear left and right wheel rim were observed to be cracked due to the collision. See photo 13 – 17 below.
