AUTOMOBILE ASSESSMENT REPORT

ASSESSMENT OF VEHICLE NO. SJU 4153 L

**EVALUATION REPORT (PAPER SURVEY) OF ACCIDENT VEHICLE NO: SJU 4153L
INSURED VEHICLE: SGJ 8638Y ACCIDENT DATE: 04/04/2018**

ADJUSTMENT ON REPAIR COST FOR VEHICLE NO. SJU 4153L

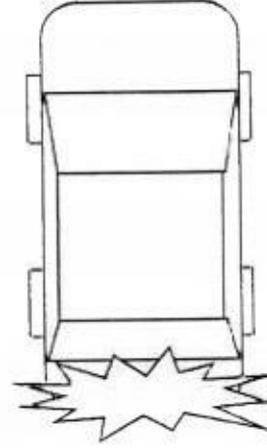
4. DESCRIPTION OF DAMAGE

At the time of the inspection, the vehicle sustained damages to the REAR portion.

Market Value:	Na
Salvage Value:	Na
Repair Limit:	Na
Estimated Amount:	\$11,570.76
Adjusted Amount:	\$9,797.36
Lump Sum:	\$7,000.00
Estimated Repair Days:	7 days
