Your Ref: TP/IP/27053/2019
Our Ref : CI/TPD19009628/N

11 June 2019

INSPECTION REPORT OF MOTORCYCLE JQR 5745

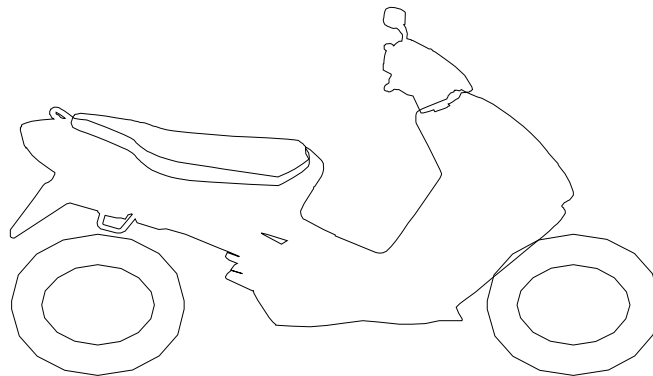
6. The condition of the 2 tyres of the Motorcycle was observed to be in serviceable condition. We did not observe any tear, burst mark(s) and/or punctured hole(s) on the sidewalls as well as across the tread of the 2 tyres. Both the tyres were observed to be sufficiently inflated for vehicular operation.
7. The tyre brand, tyre size and remaining tread depth of the 2 tyres were recorded as follows:-

Metzeler 140/70 - 17 (4mm)

Michelin 110/70 - 17 (4mm)
