Your Ref: TP/IP/00753/2019  
Our Ref : CI/TPD19009632/P

11<sup>th</sup> June 2019

**MECHANICAL INSPECTION REPORT OF MOTOR CAR SLJ 7209A**

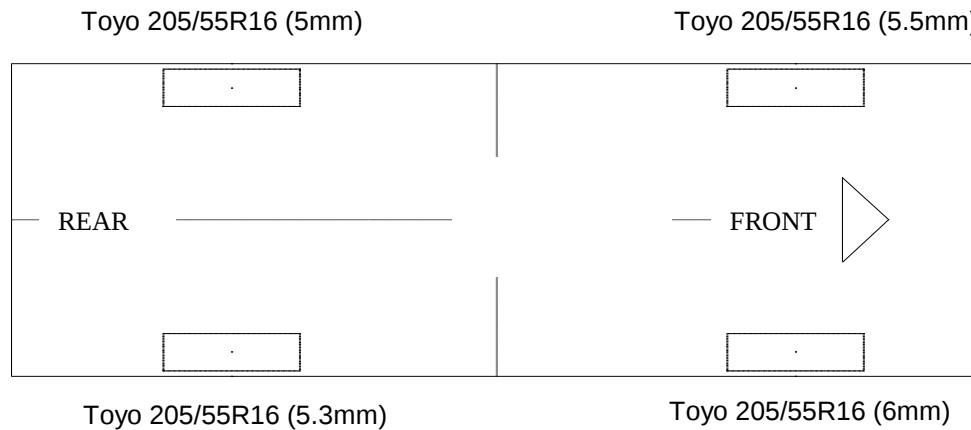
6. The condition of the Motor car's 4 tyres was observed to be in serviceable condition. I did not find any tear, cut or burst mark(s) on the outer and the inner sidewalls as well as across the tread of the 4 tyres. The 4 tyres were also observed to be sufficiently inflated for vehicular operation. The tyre brand, tyre size and remaining tread depth of the 4 tyres were recorded as follows:-
