Your Ref: TP/IP/29777/2019
Our Ref : CI/TPD19009634/P

Fatal Accident Investigation Team

MECHANICAL INSPECTION REPORT OF MOTOR JEEP GZ 8901C

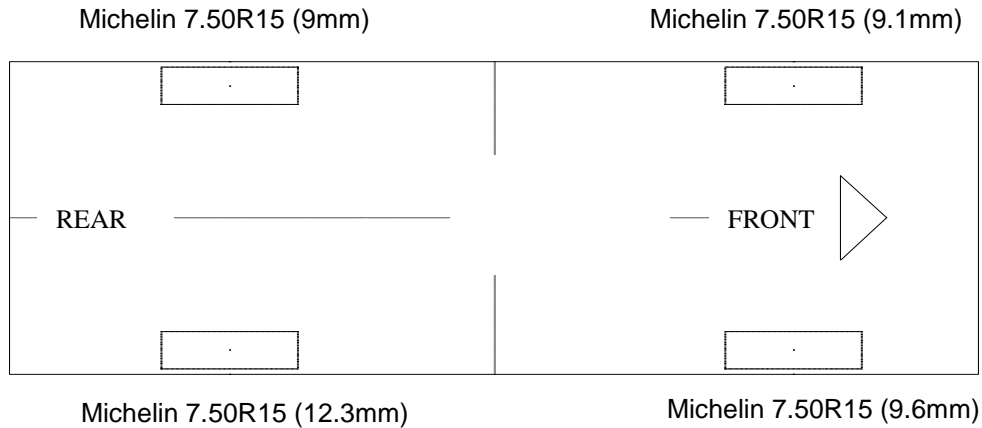
6. The condition of the Motor Jeep's 4 tyres was observed to be in serviceable condition. I did not find any tear, cut or burst mark(s) on the outer and the inner sidewalls as well as across the tread of the 4 tyres. The 4 tyres were also observed to be sufficiently inflated for vehicular operation. The tyre brand, tyre size and remaining tread depth of the 4 tyres were recorded as follows:-
