Your Ref: TP/IP/33089/2019
Our Ref : CI/TPD19011268/P

21st October 2019

MECHANICAL INSPECTION REPORT OF MOTOR LORRY GBB 5739K

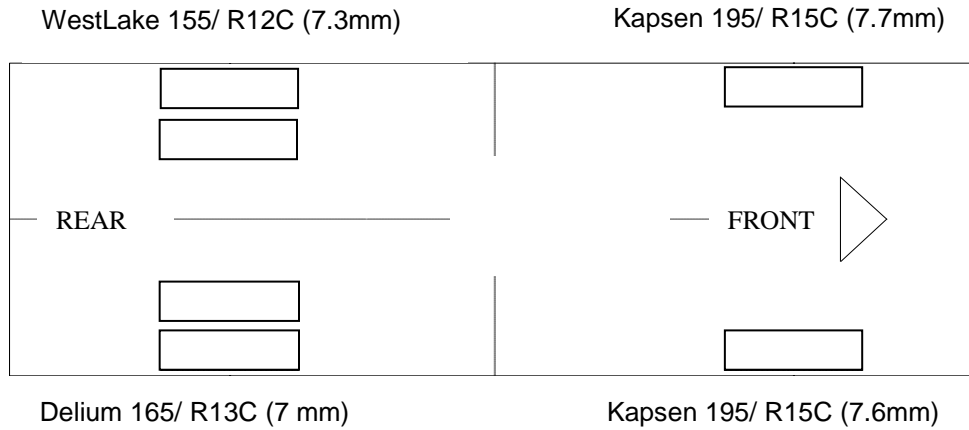
6. The 2 front tyres and 4 rear tyres of the Motor Lorry were observed to be in serviceable condition and sufficiently inflated for vehicular operation. I did not find any tear, cut or burst mark(s) on the outer and the inner sidewalls as well as across the tread of the 6 tyres. The tyre brand, tyre size and remaining tread depth of the 6 tyres of the Motor Lorry were recorded as follows:-

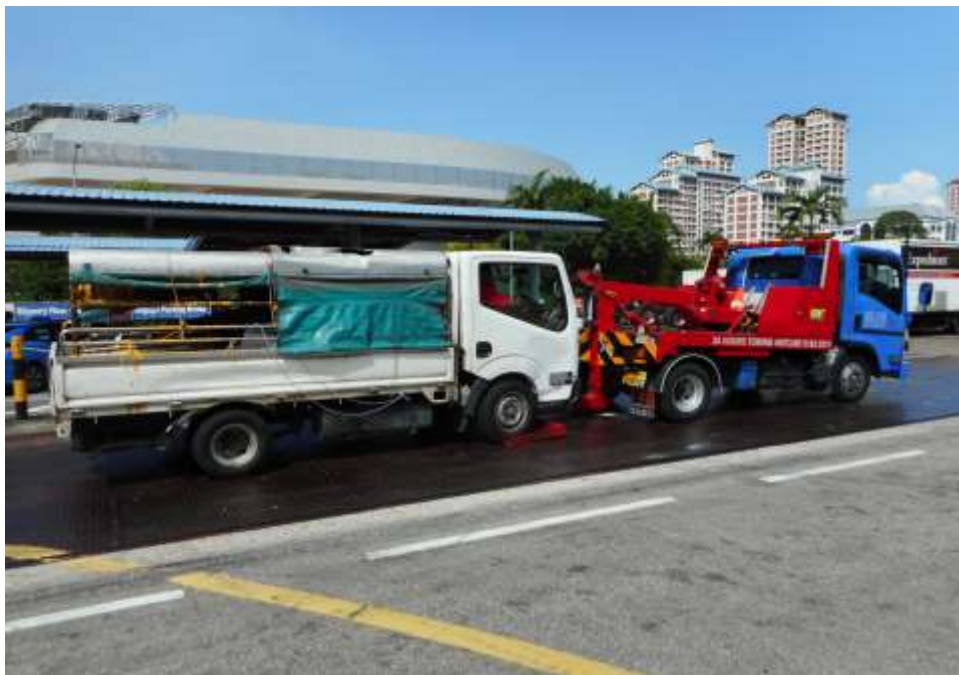
17. Given that there were signs to suggest that there were issues with the braking system of the Motor Lorry, we had requested to send the Motor Lorry for a roller brake test.
18. A Roller brake test on the Motor Lorry was conducted at STA inspection centre at Sin Ming Road on 16th October 2019 to test the brake efficiency of the Motor Lorry's braking system. Test results revealed that the Motor Lorry had failed the roller brake test. See Photo 26-32 below

Photo 26 shows the Motor Lorry towed to STA inspection centre at Sin Ming road for roller brake test the purpose is to test the braking efficiency of the Motor lorry's braking system at the point of accident.

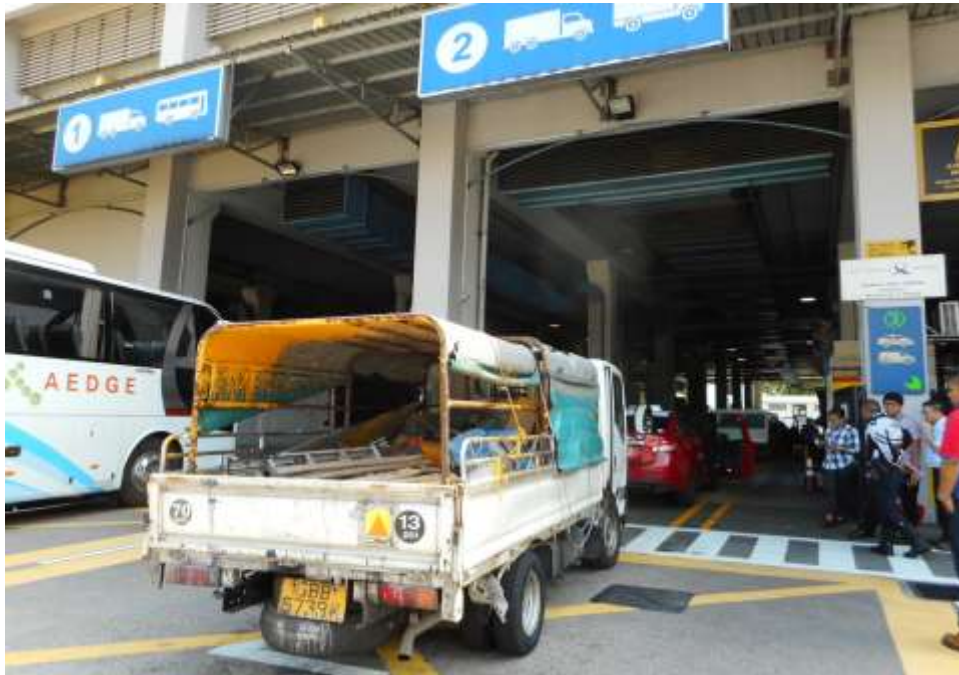
Photo 27 shows the Motor Lorry proceeding into STA inspection centre at Sin Ming road for roller brake test the purpose is to test the braking efficiency of the Motor lorry's braking system at the point of accident.
