Your Ref: TP/IP/37427/2019  
Our Ref : CI/TPD19012747/P

**Fatal Accident Investigation Team**

**MECHANICAL INSPECTION REPORT OF MOTOR VAN GBE 3035E**

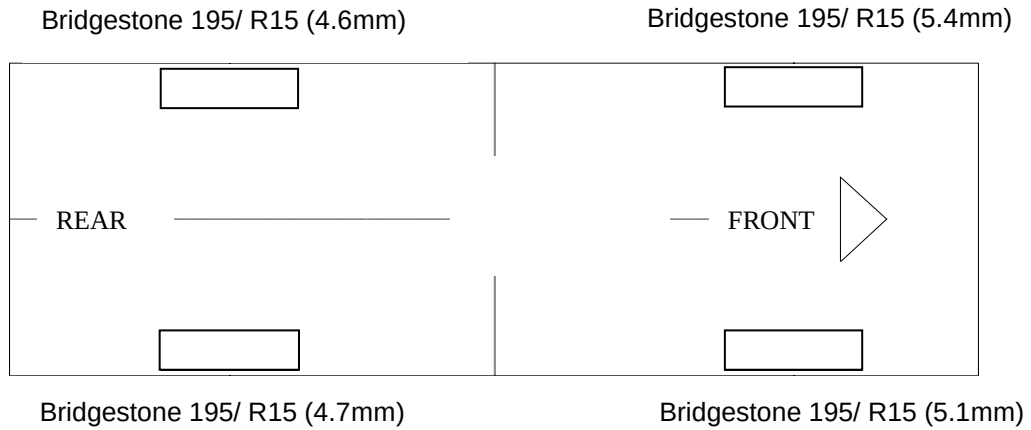
6. The 4 tyres of the Motor Van were observed to be in serviceable condition and sufficiently inflated for vehicular operation. I did not find any tear, cut or burst mark(s) on the outer and the inner sidewalls as well as across the tread of the 4 tyres. The tyre brand, tyre size and remaining tread depth of the 4 tyres of the Motor Van were recorded as follows:-
