Your Ref: TP/IP/40685/2019
Our Ref : CI/TPD19012750/P

30th July 2019

MECHANICAL INSPECTION REPORT OF MOTOR LORRY GBJ 253K

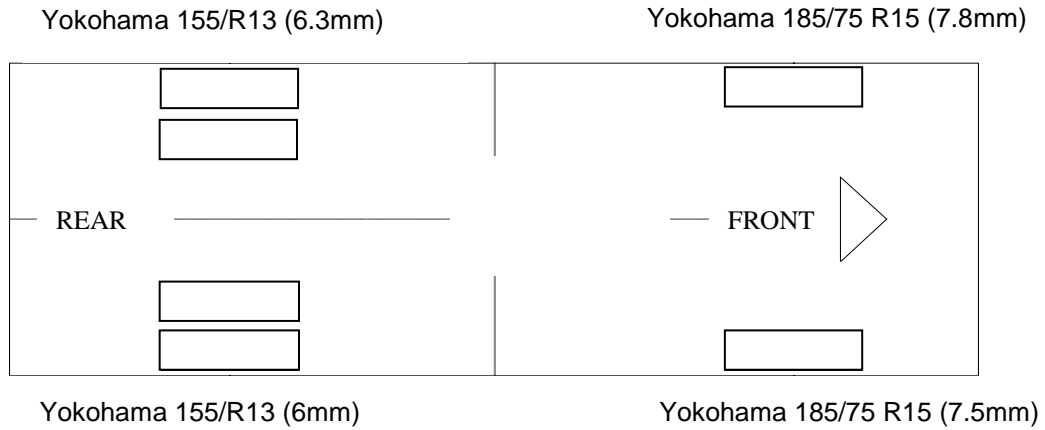
6. The 2 front tyres and 4 rear tyres of the Motor Lorry were observed to be in serviceable condition and sufficiently inflated for vehicular operation. I did not find any tear, cut or burst mark(s) on the outer and the inner sidewalls as well as across the tread of the 6 tyres. The tyre brand, tyre size and remaining tread depth of the 6 tyres of the Motor Lorry were recorded as follows:-
