Your Ref: TP/IP/40513/2019
Our Ref : CI/TPD19012752/P

3rd December 2019

MECHANICAL INSPECTION REPORT OF GARBAGE TRUCK XD 4956K

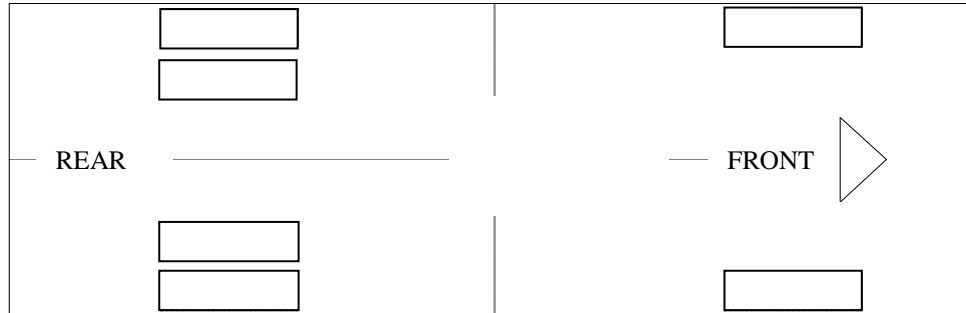
6. The 6 tyres of the Garbage Truck were observed to be in serviceable condition and sufficiently inflated for vehicular operation. I did not find any tear, cut or burst mark(s) on the outer and the inner sidewalls as well as across the tread of the 6 tyres of the Garbage Truck. The tyre brand, tyre size and remaining tread depth of the 6 tyres of the Garbage Truck were recorded as follows:-

Bridgestone 295/80 R22.5 (4.6mm)

Bridgestone 295/80 R22.5 (4.9mm)

Bridgestone 295/80 R22.5 (3.5mm)

Bridgestone 295/80 R22.5 (3.9mm)
