Your Ref: D19/4634M/PTE/JS
Our Ref : CS/FCI19013015/D

31 July 2019

MECHANICAL INSPECTION REPORT OF INSURED VEHICLE SJA 29U

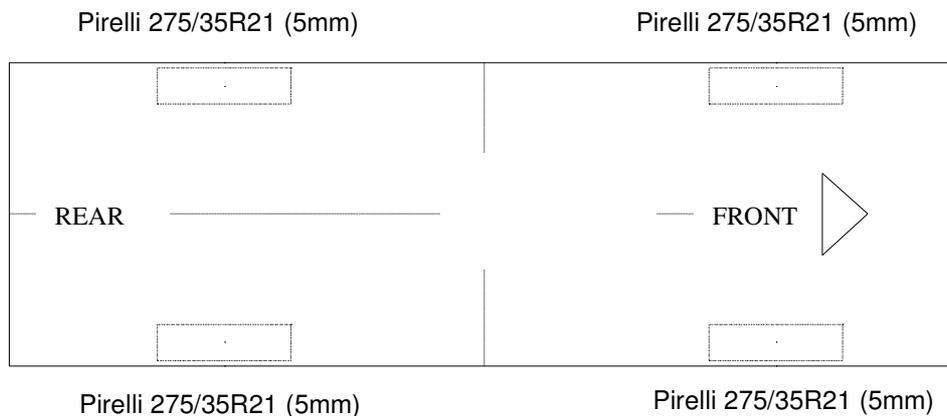
6. The condition of the Insured Vehicle's 4 tyres was observed to be in serviceable condition. I did not find any tear, cut or burst mark(s) on the outer and the inner sidewalls as well as across the tread of the 4 tyres. The 4 tyres were also observed to be sufficiently inflated for vehicular operation. The tyre brand, tyre size and remaining tread depth of the 4 tyres were recorded as follows: -
