1.		Policy Particulars	- THIRD PARTY CLAIM		
	Insured Veh.	GBE 2041T	Veh. Inspected	SJN 3481H	
	Policy No.	DMCVSN3060071800	Coverage (\$)	0.00	
	Claim No.	SNM19D203949	Excess (\$)	0.00	
	Assign From		Assign Date	27/08/2019

2.		Vehicle Partic	culars & Condition		
	Make & Model	HONDA FREED	c.c	1496	
	Engine No.	HIDDEN	Year of Reg.	2009	
	Chassis No.	GB31033276	Colour	MAROON	
	Odometer	152078	Steering	IN ORDER	
	Brakes	IN ORDER	Modification	SPORTS RIM	
	General	GOOD

ADJUSTMENT ON REPAIR COST FOR VEHICLE NO. SJN 3481H

PHOTOGRAPHS FOR VEHICLE NO. SJN 3481H

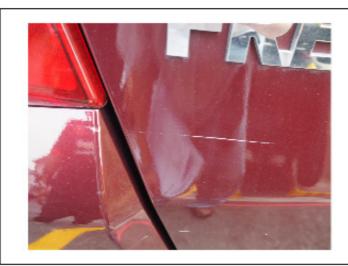
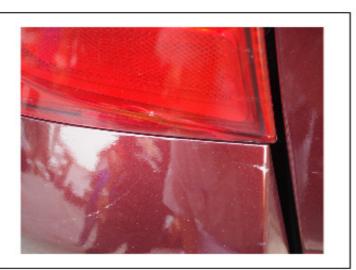
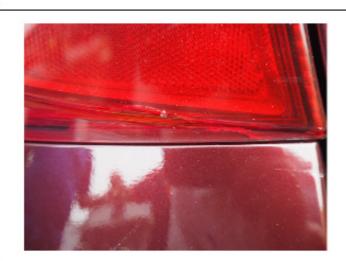
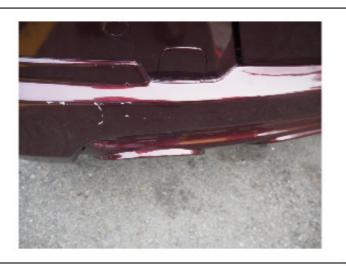
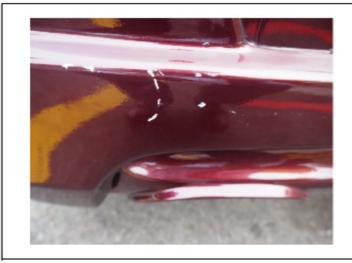
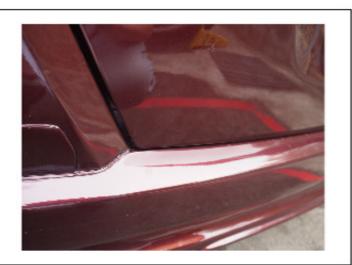
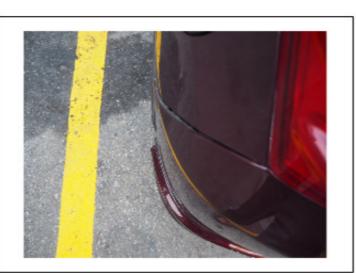
4.		Description	on of Damages		
	THE VEHICLE SUS	STAINED DAMAGES AT THE REA	AR PORTION.		
	DAMAGES SEE DI	ETAILS.			
5.		General	Information		
	Accident Date	22/08/2019	Inspection Date	27/08/2019	
	Survey held at	96 MOTORSPORTS PTE LTD			
		62/64 KAKI BUKIT AVENUE 6 SINGAPORE 417893 ARK @ KB			
5a.		Re	emarks		
		ON WAS CONDUCTED ON A"WIT CE TO YOUR INSTRUCTIONS, W		REPAIRS.	
5b.	Estimate Days of Repair				
	ESTIMATED NOR	MAL PERIOD FOR REPAIR:	5 Working Days
