Your Ref: DHOM110096520909
Our Ref : CS/UOI19015641/N

9 September 2019

**TECHNICAL INVESTIGATION REPORT OF SMOKE INCIDENT INVOLVING THE
INSURED VEHICLE GBB 6579Z ON 2 SEPTEMBER 2019**

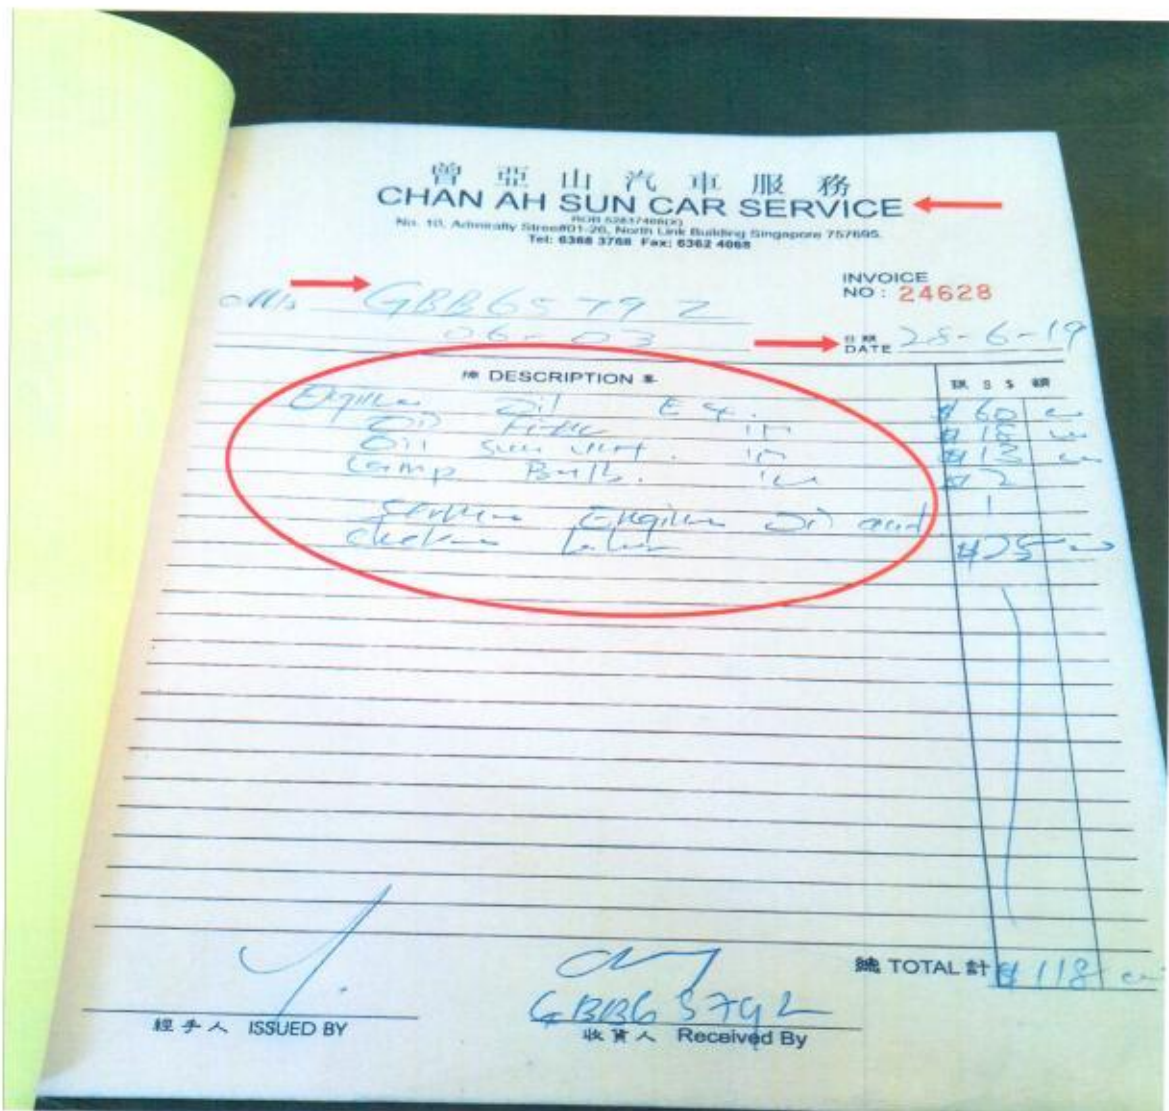
INVOICE NO: 24628
DATE: 28-6-19

Invoice 1 shows the latest servicing done on the Insured Vehicle at CAS on 28 June 2019 (red arrows). The servicing package included changing of engine oil and oil filter. The oil sump bolt was replaced (circled).
